**NUMBER:** 23-019-14

Electronic Back Light Grid May Short Out To Carbon Fiber Inner Panel

2013 (ZD) Viper

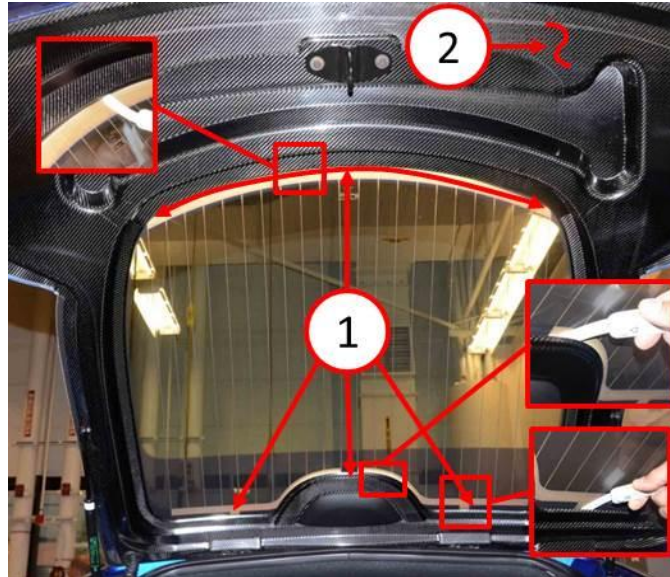
**Fig. 1 Gap Inspection**

1. Inspect the gap between the liftgate glass silver band and the liftgate around the top and bottom of the liftgate assembly as shown in (Fig. 1).

- 1 - Inspect between liftgate inner and back glass
- 2 - Liftgate inner

- 
3. Is the clearance between the glass silver band and the liftgate flange less than .25mm?
    - a. Yes>>> Remove and replace the liftgate glass. Refer to the detailed repair procedures available in: DealerConnect> TechCONNECT under: Service Info> 23 - Body> Stationary Glass> Glass, Liftgate> Removal/Installation.

- b. No>>> Proceed to [Step #4](#).
  4. Is the clearance between the glass silver band and the liftgate flange greater than 1.5mm?
    - a. Yes>>> Turn on the heated rear defrost function and allow to cycle one time until it automatically shuts off. If no damage occurs to the liftgate glass near the widows peak, return the vehicle to the customer or dealer inventory. If there was damage, remove and replace the liftgate glass. Refer to the detailed repair procedures available in: DealerConnect> TechCONNECT under: Service Info> 23 - Body> Stationary Glass> Glass, Liftgate> Removal/Installation.

- b. No>>> Remove and replace the liftgate glass. Refer to the detailed repair procedures available in: DealerConnect> TechCONNECT under: Service Info> 23 - Body> Stationary Glass> Glass, Liftgate> Removal/Installation.

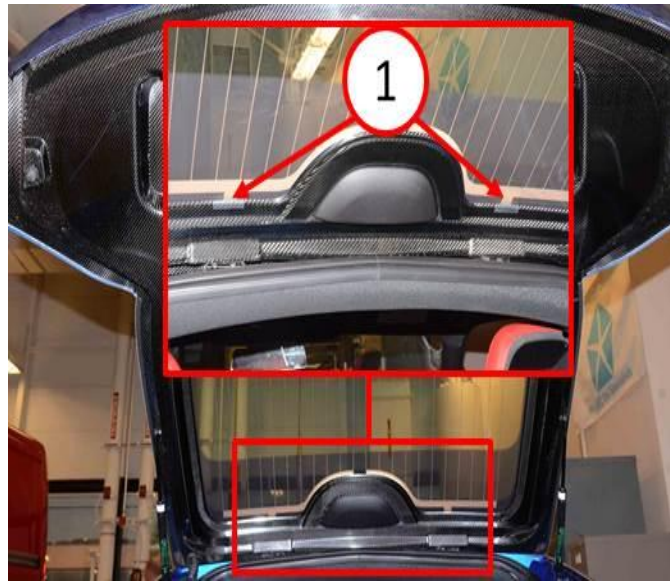
**Fig. 2 Anti-Squeak Tape Installation**

1 - Anti-squeak tape installation areas

- 
2. Is the clearance between the glass silver band and the liftgate flange between .25mm and 1.5mm?
    - a. Yes>>> Clean the liftgate edge with isopropyl alcohol. Cut Mopar p/n 05019054AA anti-squeak tape in 1/4”(6.35mm) pieces and apply one piece at the top left and right side of the liftgate edge (Fig. 2). The tape is to wrap around the edge of the liftgate panel, providing a barrier to it and the glass.
    - b. No>>> Proceed to [Step #4](#).
