Safety Recall Circular

Code: **VN**

**Subject: 2004 Model Year Volkswagen Touareg Vehicles
Check/Replace Rear Seat Belt Buckles**

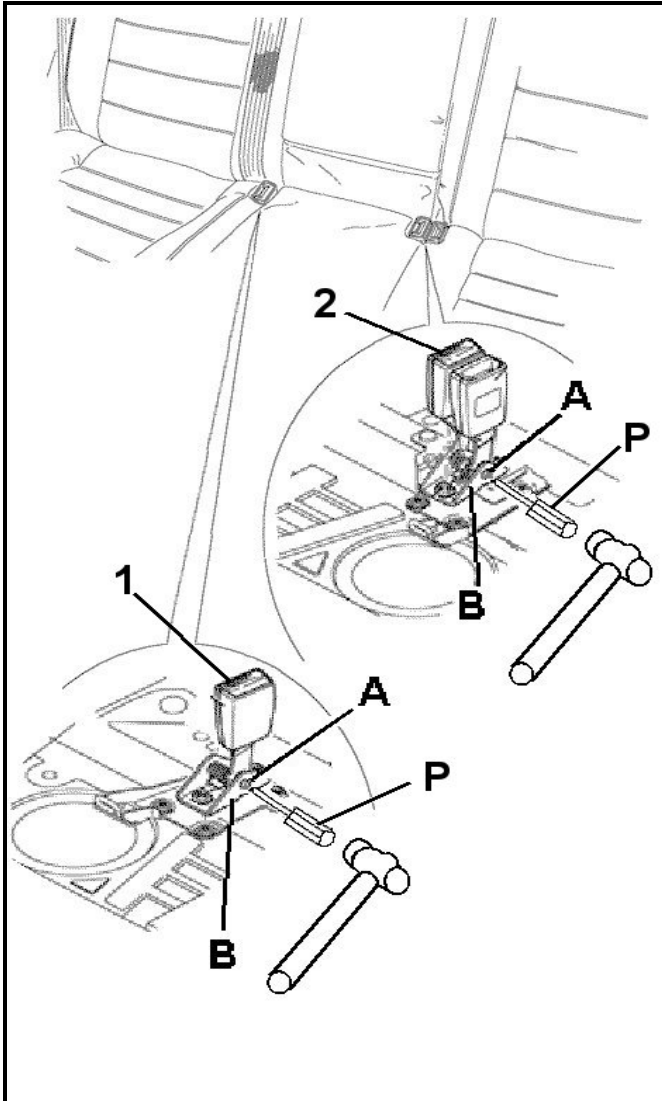
Problem Description Volkswagen has found that some 2004 model year Touareg vehicles may have have a rear seat belt latch attachment bolt that may be insufficiently riveted, which may result in a reduced capability of the belt latch to withstand the applied loads. In the event of a crash an occupant may not be properly restrained, which could result personal in injury.

⇐ The end of the mounting pin -A- on the left seat belt double press button buckle -2- and right seat belt press button buckle -1- is flared to prevent it from coming out of the anchoring bracket -B-

IMPORTANT! The flared end of the mounting pin is on the left side of each seat belt press button buckle

⇐ Use a flat punch -P- with a hammer and lightly hit each mounting pin 2 or 3 times:

- If the mounting pin cannot be moved out of the anchoring bracket -B-, no further work is required, reposition seat bottoms and close doors
- If the mounting pin does move out of the anchoring bracket -B-, **proceed to Section B**
