Service Action Circular

Code: **VQ**

Subject: 2004 Model Year Volkswagen Touareg Vehicles Modify Rubber Around Power Steering Fluid Line and Transmission Fluid Line Located Behind Radiator Grille

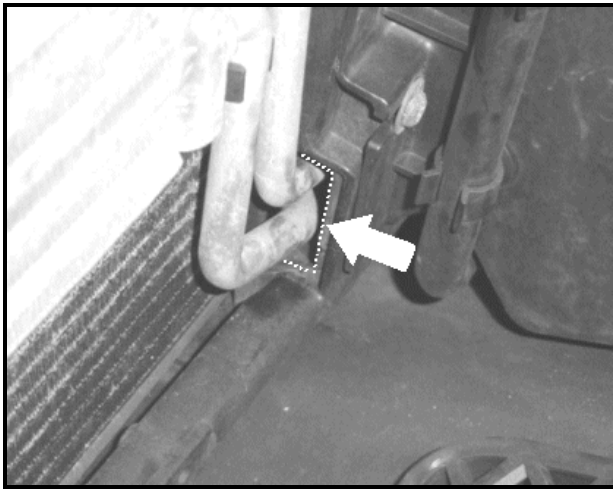
Problem Description Volkswagen has found that a rubber part can rub against the power steering and/or transmission fluid lines located behind the radiator grille. In rare cases, this rubbing can lead to corrosion of the lines and possibly even a fluid leak.

⇐ At left bottom corner of radiator, use a small knife and carefully cut away the rubber contacting the power steering fluid lines

IMPORTANT! Only cut away rubber contacting the fluid lines from the area inside dotted lines -arrow-

CAUTION: DO NOT DAMAGE RADIATOR OR FLUID LINE WHEN REMOVING RUBBER
