## Please give copies to all Technical Bulletin

Subject: MIL is ON, DTCs P1411, P1423 are Stored in DTC

Model(s): Touareg

Number: **05–09**

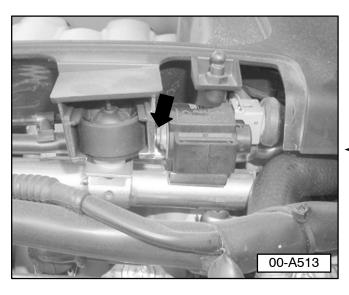
May be caused due to lack of clearance between the engine cover and the Secondary Air Injection Solenoid Valve -N112-.

Secondary Air Injection Valve, Solenoid Valve -N112- is damaged when left rear corner of engine cover are installed after service has been performed to engine:
