Subject: **Battery, Maintaining Charge During Repairs**

Number: **03-01**

Model(s): **Touareg**

Date: **June 20, 2003**

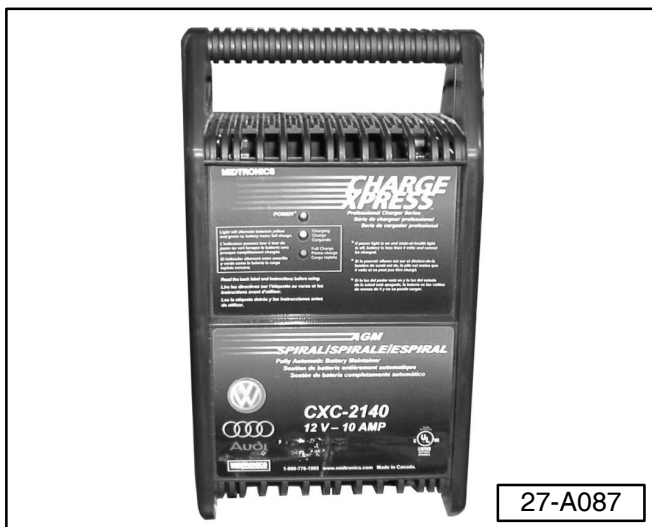
Rapid battery discharge occurs while repairing vehicle with ignition switched ON.

Occurs due to high current draw of headlights and load from other vehicle systems with ignition switched in the ON position (vehicle not running).

◀ Any repair procedure which requires the Ignition to be switched ON or the hood open will require the use of a battery maintainer such as the CXC-2105 (each dealer received two in the Touareg automatic tool shipment announced in Tools Equipment Service Circular VTE-03-06 dated May 27, 2003).
