# Technical Bulletin

Subject: **Rear Hatch Glass, Open Warning Displayed In  
Multi-Function Display (BC)**

Number: **04-01**

Model(s): **Touareg**

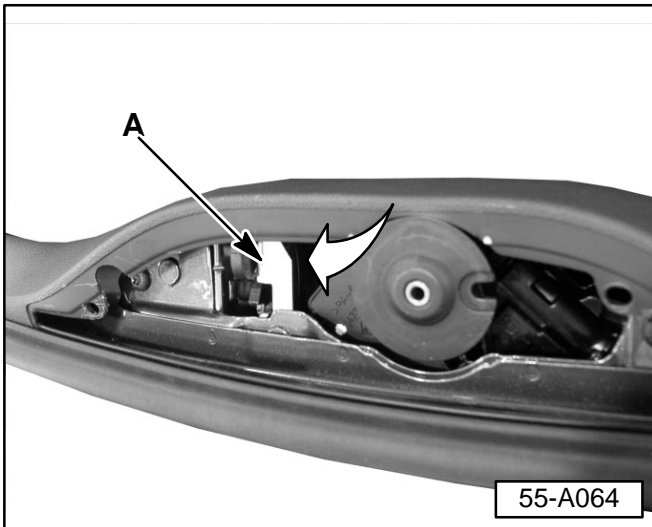
- Open rear window.
- Remove rear wiper motor trim cover.
- ◀ - Check Part No. -white arrow- on side of rear hatch glass latch -A-.

If rear hatch glass latch Part No. is 7L0 827 506D:

If rear hatch glass latch Part No. is 7L0 827 506C:

- Replace rear hatch glass latch. See Repair Manual, *Repair Group 55, Hinged Window Lock, Removing and Installing.*

- ◆ Order Part No. **7L6 827 501A** to receive correct part.
