Subject: Exterior Door Handle, Remains In Open Position

Number 05-02

Model(s): Touareg

2004 ► 2005 to VIN: 7L\_5D070270 Date: June 10, 2005

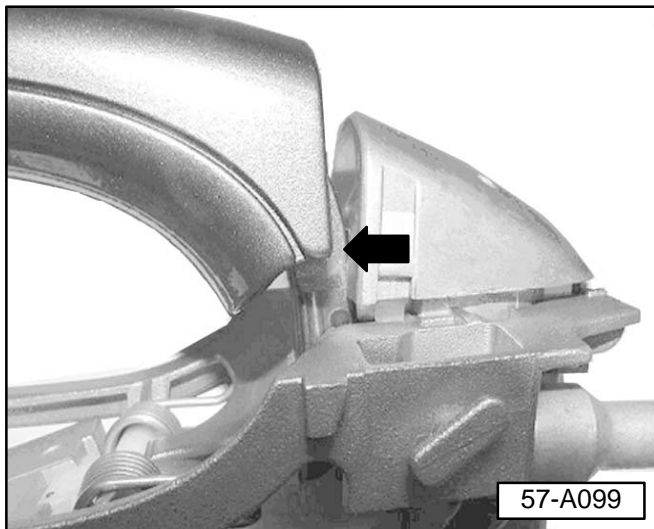
- ◀ ◆ Outside door handle rubs on tower (arrow) with visible scoring.

- Remove and disassemble door handle.

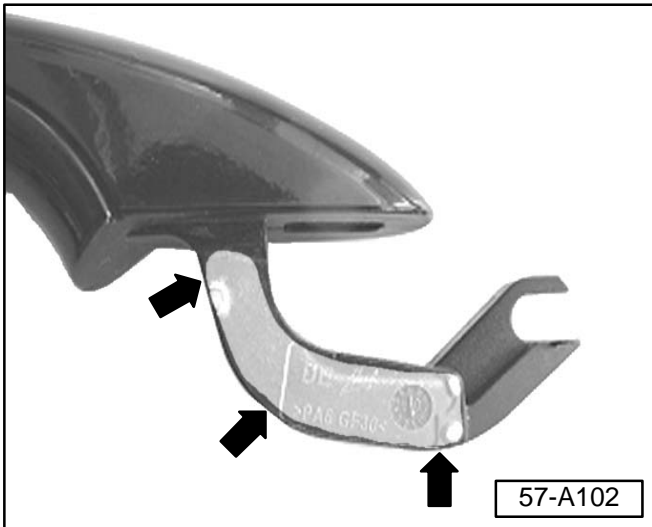
- ◆ Severe friction between individual components.

- Remove and disassemble door handle.
- ◀ – Grind off two small notches (arrow), one each side, on the door handle.

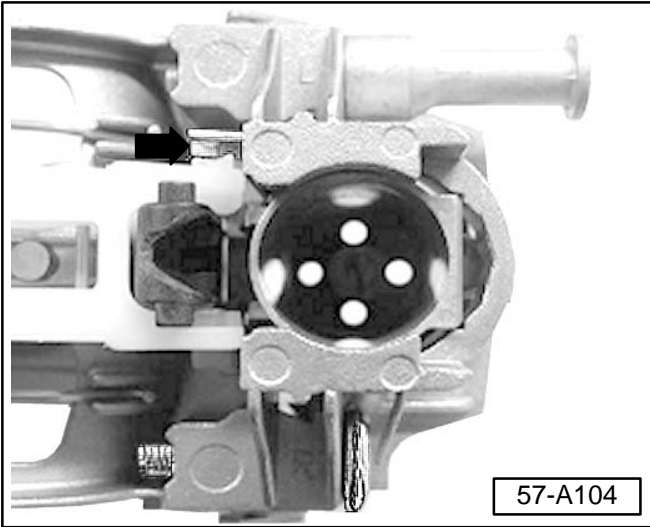
- ◆ Plastic bell crank can jamb behind leaf spring.

- ◀ – Grind a little material off of white bell crank to ensure clearance.
- Assemble door handle, install and ensure correct operation.
