Technical Bulletin

Subject: **Front Armrest Cupholder, Latch Mechanism
Inoperative**

Number: **03-03**

Model(s): **Touareg**

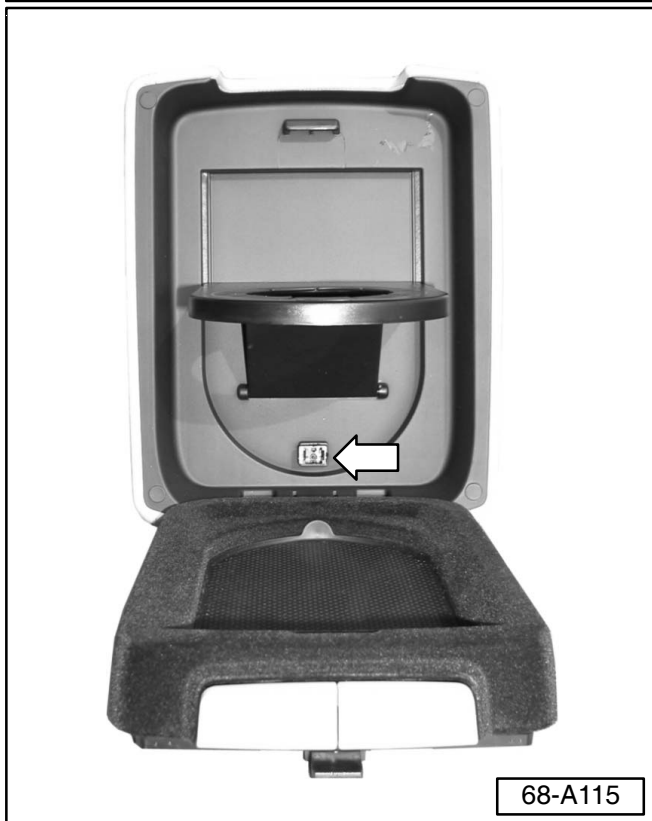
- ◀ Front armrest cupholder latch mechanism (arrow) is broken, cup holder will not stay latched in the closed position.

DO NOT replace armrest for this condition.
