# Technical Bulletin

Subject: **Rear Upper Seat Cover Makes Contact with Lower Seat Frame** Group: **72**

Number: **05-04**

Model(s): **Touareg**

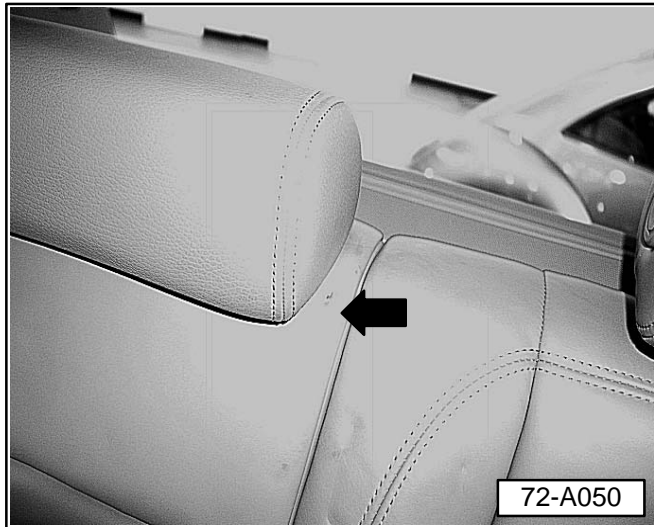
Left upper corner of right rear seat back makes contact with lower seat frame when utilizing fold down seat.

◀ Inspect right rear seat back cover in upper inboard side (arrow) for signs of chafing.

If chafing is present modify seat right lower seat frame as follows:

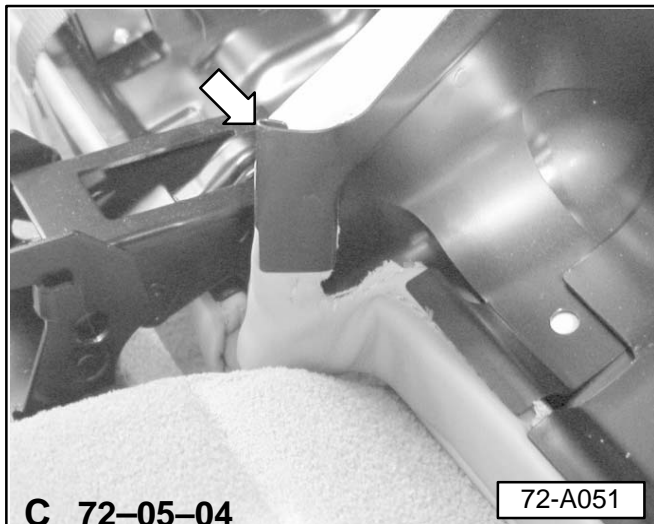
Inspect inboard seat frame hinge, on right seat for protrusion past seat material.

◀ If lower seat frame metal is equal to or above seat cushion material (arrow), reshape seat frame corner as follows:
