Technical Bulletin

Subject: **Module, Vehicle Position Recognition Control -J603-,
Diagnosis**

Number: **05-03**

Model(s): **Touareg**

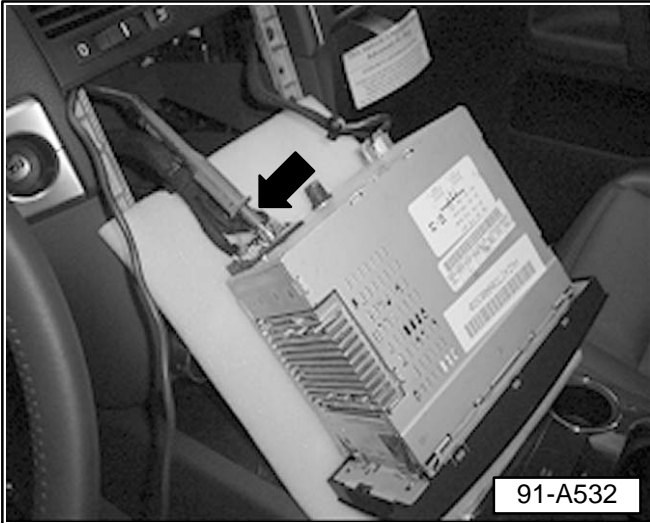
- ◀ - Connect the VAS Voltage test positive probe (arrow) to the CAN Low terminal, Pin 10 – Orange/Brown wire.

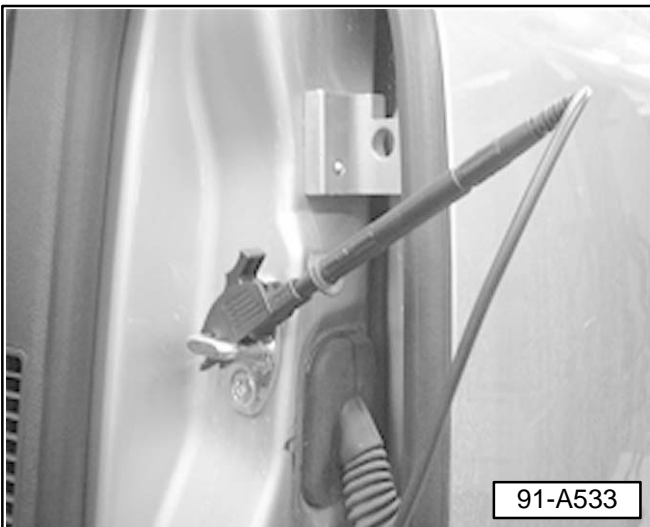
- ◀ - Connect the VAS 5051 Voltage test negative probe to the door striker.

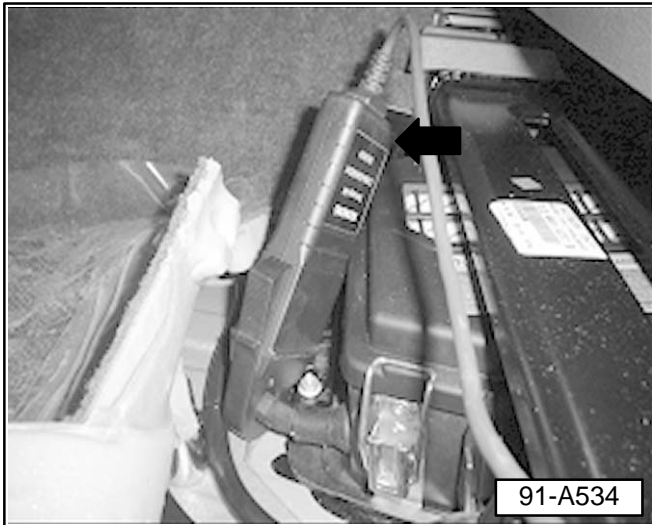
◀ – Connect VAS 5051 50A current clamp (arrow) on the Negative battery cable in front of the driver seat.
