# Technical Bulletin

Subject: **Headlights, Moisture Accumulation**

Number: **03-01**

Model(s): **Touareg**

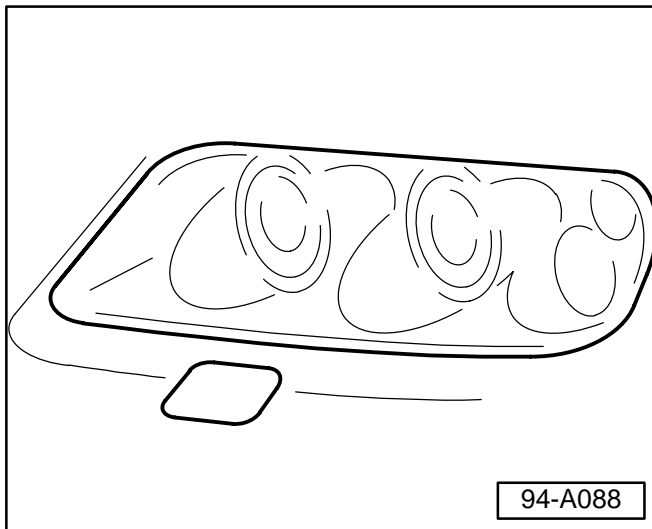
◀ Headlight assemblies are vented and will collect moisture on the headlight lens under some climatic and geographical conditions.

Moisture will evaporate after headlights have been ON for approx. 10 minutes.

- NO action is necessary. DO NOT replace headlights for this condition.
