Technical Bulletin

Tail Light Assembly, Difficult to Remove or Lens Cracks During Removal

94 06 18 Dec. 2, 2006 2008512 Supersedes T. B. Group 94 number 05-01 dated Feb. 3, 2005 due to inclusion into ElsaWeb.

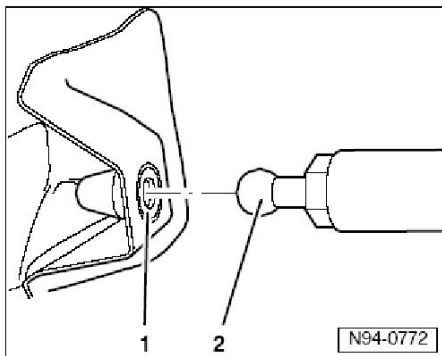
Tail light assembly is hard to remove or lens cracks during removal.

May be due to excessive retention force of the tail light retainer installed in the body.

After removal of tail light assembly for service (i.e. removal due to damage or installation of a trailer hitch):

- Replace existing retainer -1- (white) with new improved retainer Part No: 7L6905229 (black).
- Reinstall Tail light assembly.
