# Safety Recall Circular

Code: **WS**

August 2003

## **Subject: 2004 Model Year Touareg Vehicles Check/Correct Tire Pressure Monitoring System (TPMS) Wiring Harness Routing**

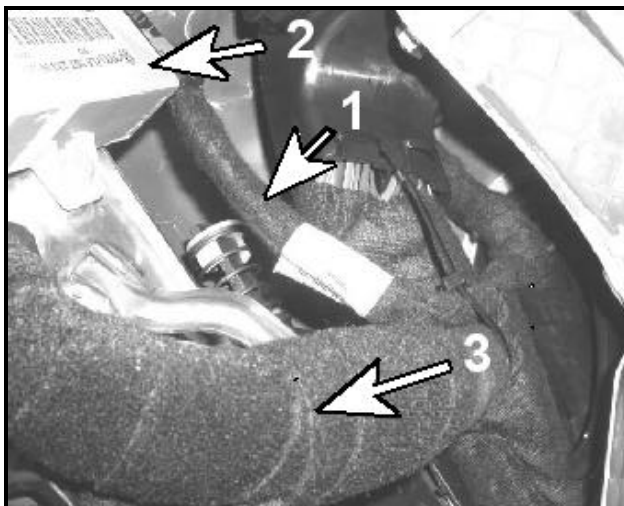
- Check position of Wiring Harness -1- going to Tire Pressure Monitor Control Module -2-
- If Wiring Harness -1- is routed behind and to the right of the main harness -3- as shown, no further work is required; reconnect wiring harness to diagnosis plug and wiring harness to footwell light, and reinstall footwell cover securing it with 2 screws, otherwise proceed to next step.

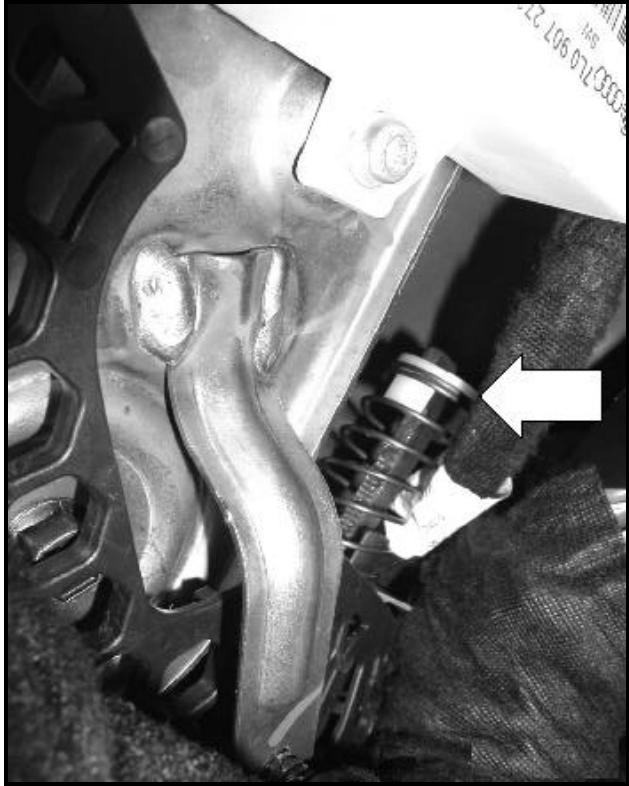
This safety recall involves the Tire Pressure Monitoring System (TPMS) wiring harness, which may not have been routed properly on some 2004 Touareg vehicles during assembly. An improperly routed TPMS wiring harness may contact the parking brake cable spring. If this happens, the TPMS wiring circuit may be interrupted, resulting in an inoperative TPMS and a potential short-to-ground connection that could potentially result in a fire.

- ← If Wiring Harness is routed next to parking brake cable spring -arrow-, proceed to next step:
- Disconnect connector from the Tire Pressure Monitoring Control Module located on lower A-pillar
