Technical Bulletin

RVU - Rain Sensor, Installing (OT)

00 06 11 Oct. 18, 2006 2013193

Model(s)	Year	Eng. Code	Trans. Code	VIN Range From	VIN Range To
Touareg (US only)	2007	All	All	7L_7D000001	7L_7D034999

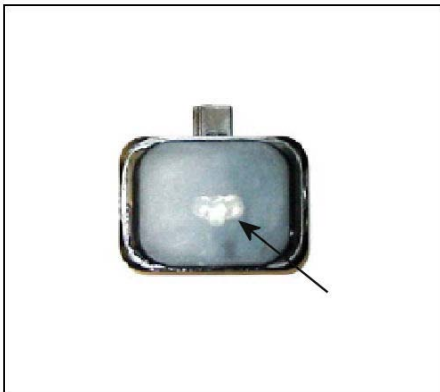
- Identify rain sensor 1K0955559R/T (there is only one set of diodes in the center of the part that contacts the windshield).

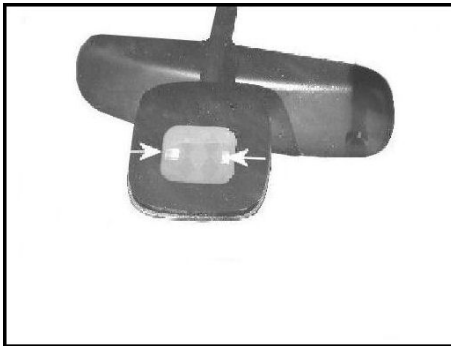
The improved rain sensor is identifiable by the white optical receptors - arrows-, or if viewed closely, the stacked diamond shape through the middle of the sensor.

- Install improved rain sensor Part No: 1K0955559AB.

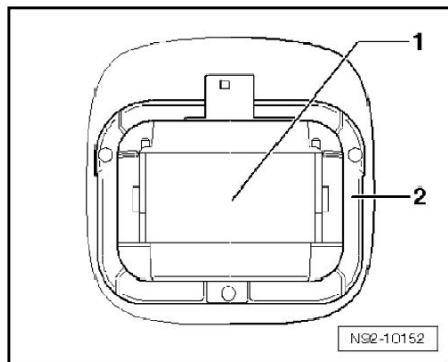
Upper shell of sensor is easily detached and may break when removing (prying). Use care to ensure complete sensor is removed from frame.

- Using a screwdriver, pry Rain Sensor - G213- or Rain/Light Recognition Sensor - G397- -1- from bracket -2-.
