Technical Bulletin

Subject: **Airbag Monitoring Light ON, Passenger Occupant Detection System, DTC 02511 014 Stored in Memory**

Number: **05-07**

Date: **May. 23, 2005**

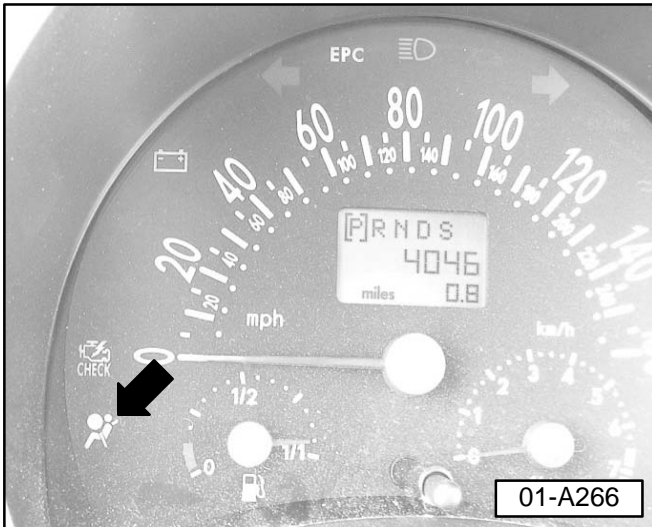
◀ After switching ignition ON, Airbag Monitoring indicator light stays illuminated and DTC 02511 014 "Seat Occupied Recognition Control Module Fault" is stored in DTC memory.

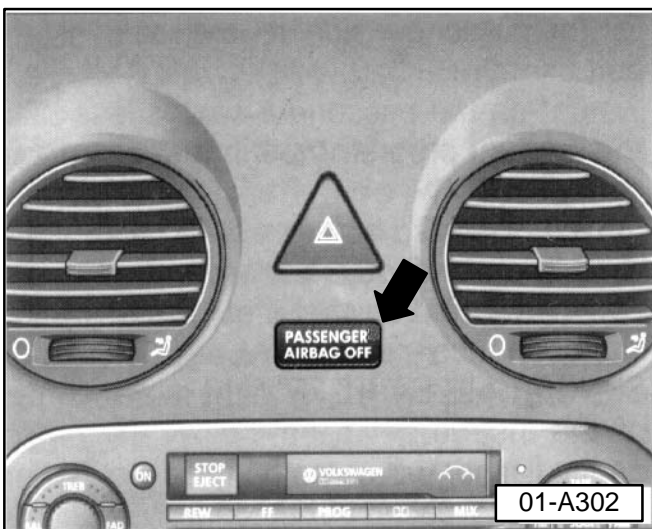
- ◀ "PASSENGER AIRBAG OFF" indicator light, in the center of the instrument panel, will stay illuminated during the first key-ON cycle.
- Airbag control module will disable the passenger airbag module during the first key-ON cycle when this DTC is stored to memory, and the "PASSENGER AIRBAG OFF" indicator will alert occupants that the airbag has been disabled.
 - "PASSENGER AIRBAG OFF" indicator will continue to operate properly during this fault.
