Technical Bulletin

Drivetrain Binding/Tires Scrubbing During Low Speed Maneuvering, ESP Light in Instrument Cluster ON or Flashing

01 06 08 Jul. 12, 2006, 2011930, Supersedes T.B. Group 39 Number 04-02 dated June 21, 2004 due to updated procedure and bulletin being removed from Required Vehicle Update category.

Model(s)	Year	Eng. Code	Trans. Code	VIN Range From	VIN Range To
Touareg	2004 - 2006	All	All	All	All

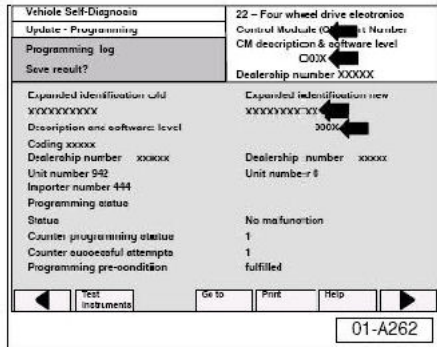
- Similar screen appears.

Old software level is still displayed at (arrows). New software level is not displayed until process is complete and fault memories have been erased.

- Print this screen.
- Attach print to vehicle Repair Order.

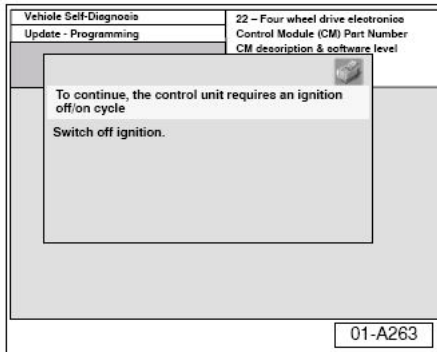
Once “Update - Programming” (flashing) is complete, the Differential Control Module must be re-initialized.

- Select the forward arrow button.
- The tester requests you to switch the ignition OFF.
- Switch ignition OFF.

Wait at least 20 seconds before switching the ignition back ON (failure to wait at least 20 seconds may damage the Control Module).
After waiting 20 seconds:
Switch ignition ON.

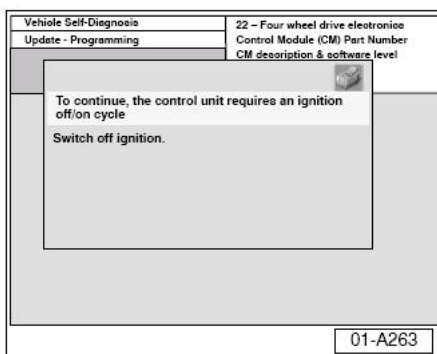
Due to the CAN bus system, fault messages will be stored in various Control Modules during programming.

- To erase ALL fault memories, confirm by selecting the forward arrow button.
