# Technical Bulletin

Subject: Flexible Fuel (FF) Sensor -G133-, Replacing (B5)

Number: 05-02

Model(s): Touareg V10 (Eng Code BKW)

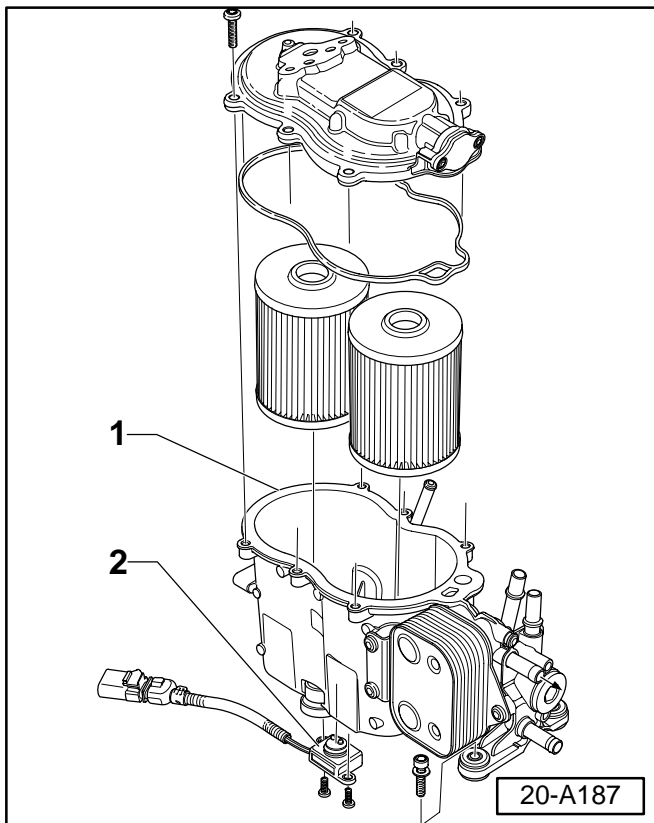
Replace Flexible Fuel Sensor -G133- and re-prime fuel system.

- Disconnect fuel supply and return hose from fuel filter housing (see Repair Manual Group 20 *Fuel supply*, Fuel filter, assembly overview).
- Connect suction pump VAS 5226 to water drain connection.
- Loosen sealing plug of water drain and operate suction pump until fuel no longer flows out.
- Tighten sealing plug of water drain to 3 N.m (26.6 in.lbs.).
- ◀ - Remove fuel filter housing -1- (see Repair Manual Group 20 *Fuel supply*, Fuel filter, assembly overview).
- Replace Flexible Fuel Sensor -G133- item -2- with Part No: 07Z 907 666B and tighten fasteners to 3 Nm (26.6 in. lbs.).

- Install fuel filter housing (see Repair Manual Group 20 *Fuel supply*, Fuel filter, assembly overview).
