Technical Bulletin

Subject: **Battery, Maintaining Charge During Repairs**

Number: **03-03**

Model(s): **Touareg**

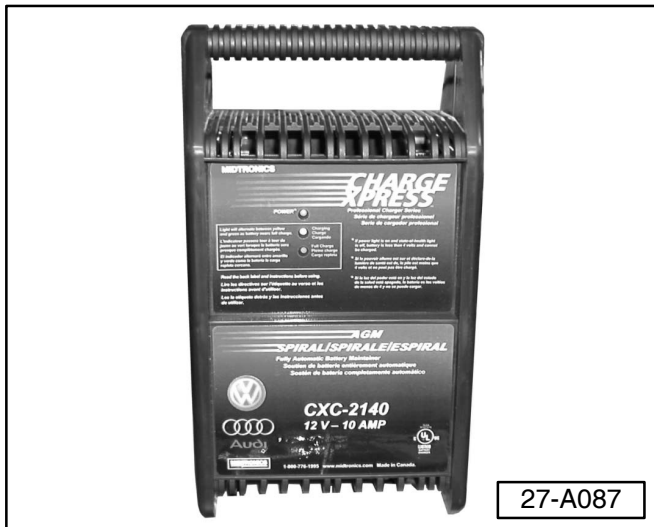
The CXC 2140:

- Is a 12 Volt, 10 Amp, fully automatic battery charger and can be used for multiple vehicle types.
- Will provide 10 amps to the system and will maintain charge with headlights ON.

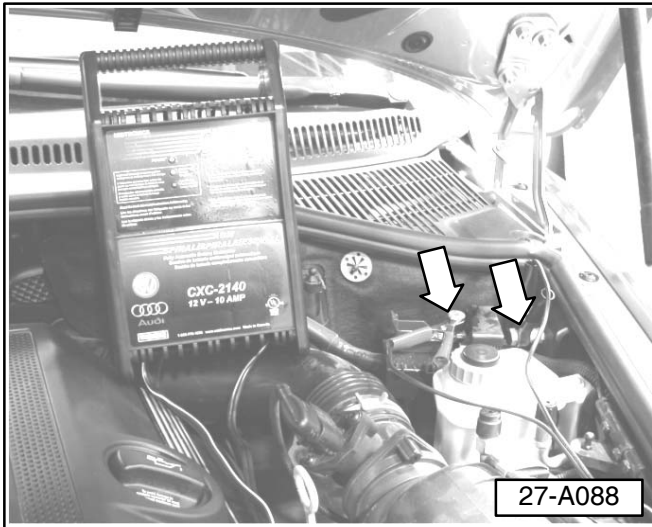
- ◀ – Connect charger to appropriate terminals in engine compartment (shown).

Any repair or diagnostic work must be done with a fully charged battery. For routine PDI or diagnostic checks with VAS 5051/5052 the battery maintainer CXC 2140 must be connected to the battery posts in the engine compartment. Headlamp fuses 35 (LH) and 17 (RH) should be removed to reduce battery discharge (This will introduce system faults that must be erased at conclusion of the repair).
