Technical Bulletin

Subject: Starter, Does Not Crank, Engine Does Not Start; Key Cannot be Removed from Ignition Switch

Number: 05-01

Model(s): Touareg

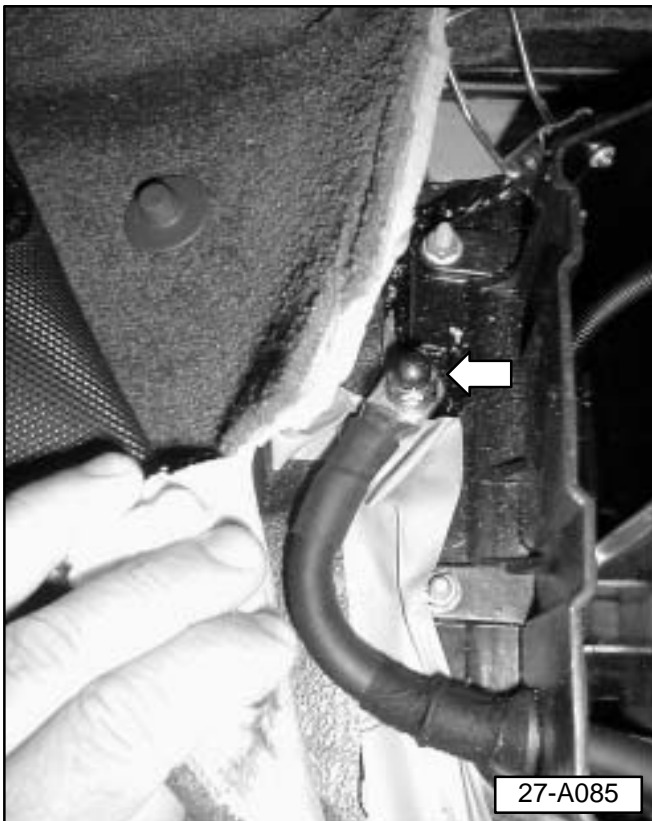
- Move driver seat to most rearward and highest position.
- Remove carpeted cover trim to access Ground (GND) stud.
- ◀ - Remove nut (arrow) for battery Ground (GND) strap from chassis Ground (GND) stud.

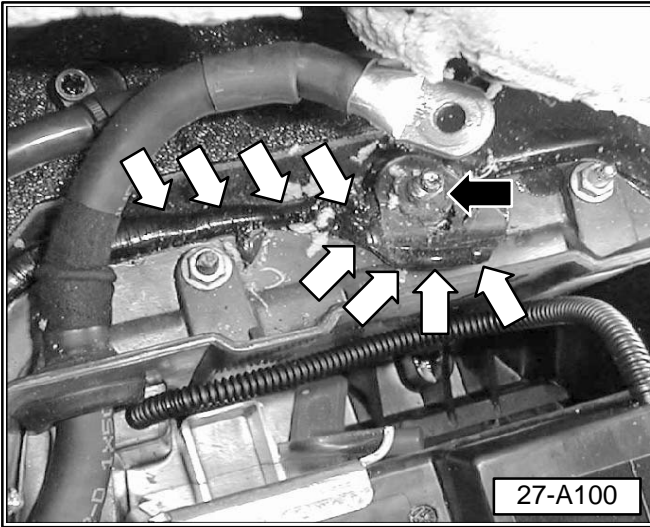
May be caused by low battery voltage due to poor contact at the battery chassis Ground (GND) strap as a result of black silicone like substance (sealant) on the Ground (GND) terminal and Battery Ground (GND) strap.

- Inspect chassis Ground (GND) stud and strap for black silicone substance.

◀ The black silicone substance used to seal the battery box -white arrows- may have been over applied and reached the Ground (GND) stud -black arrow-.

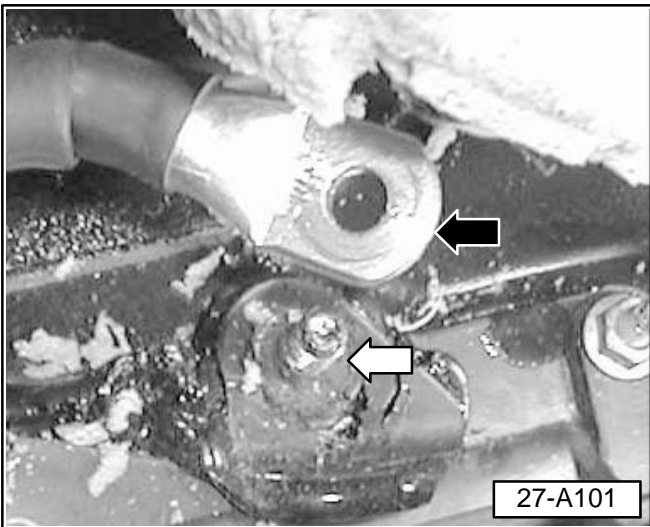
◀ If silicone substance is found:

- ◆ Battery Ground stud threads or bottom shoulder -white arrow- are not clean and bright.

- Clean chassis ground stud and underside of Ground (GND) strap -black arrow- using a brass wire brush.

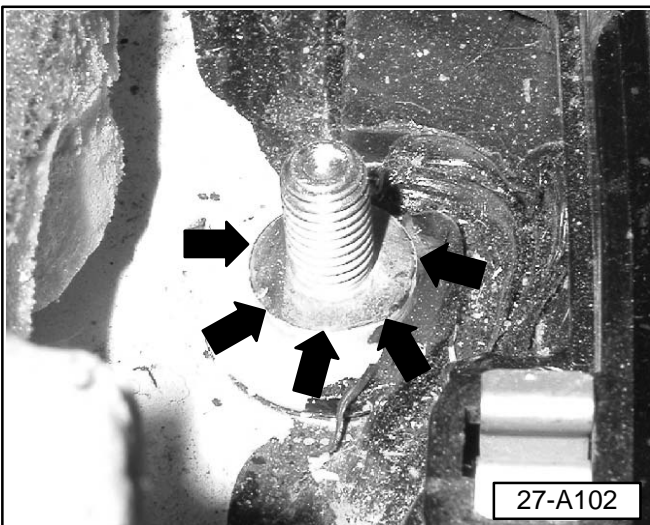
◀ ◆ Entire Ground (GND) stud including stud shoulder -arrows- should be clean and bright.

- Attach battery Ground (GND) strap to stud using nut (previously removed).

Nut Torque = 20 Nm ± 2 Nm
