# Technical Bulletin

Subject: Tire Pressure Monitoring System, Antenna Update

Number: 04-02

Model(s): Touareg with Tire Pressure  
Monitoring System

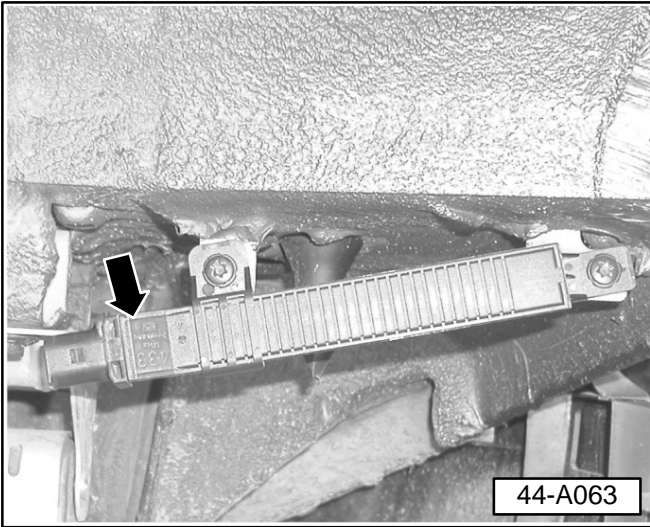
## Inspection

- Remove wheel liner in left rear wheelhouse.
- Check Tire pressure monitoring antenna location.

◀ If Tire pressure monitoring antenna is in revised location -arrow-:

- No Service Action is required. DO NOT complete this technical bulletin.

If Tire pressure monitoring antenna is in original location:

- Perform the following two steps in order.

1. Relocate left rear Tire pressure monitoring antenna.
2. Reassemble vehicle and follow "store tire pressure values" instructions.
