Technical Bulletin

Front Door Panel, Vinyl Peeling Away Near Door Glass

70 06 09 Nov. 17, 2006, 2005495, Supersedes Technical Bulletin Group 70 number 03-03 dated Sep. 10, 2003 due to inclusion into ElsaWeb.

Model(s)	Year	Eng. Code	Trans. Code	VIN Range From	VIN Range To
Touareg	2004	All	All	7L_4D000001	7L_4D013328

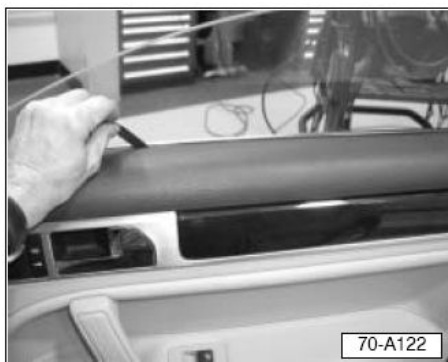
With new door panel installed, check Window to door panel gap as follows:

- Lower window completely.
- Raise window to approx. 1/3 closed position.
- Slide Special Tool No: JC4360 (0.3 mm feeler gauge) between glass and door panel from front to rear of panel.

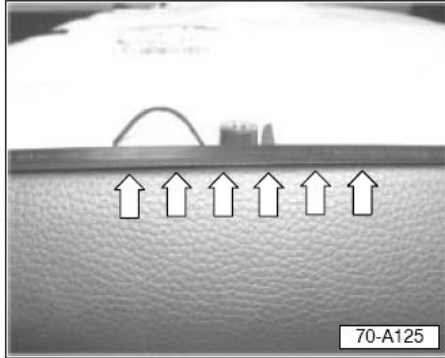
This creates a minimum of 0.5 mm gap between plastic locator and the door panel vinyl.

- Insert Special Tool No: JC4350 (0.5 mm feeler gauge) between panel and plastic locator channel at area previously marked with tape (near arrows).
