Technical Bulletin

Subject: Radio, Insufficient Bass Output (BE)

Number: 04-06

Model(s): Touareg with Radio Navigation 2004 ► 7L94D015720
System (Sound II)

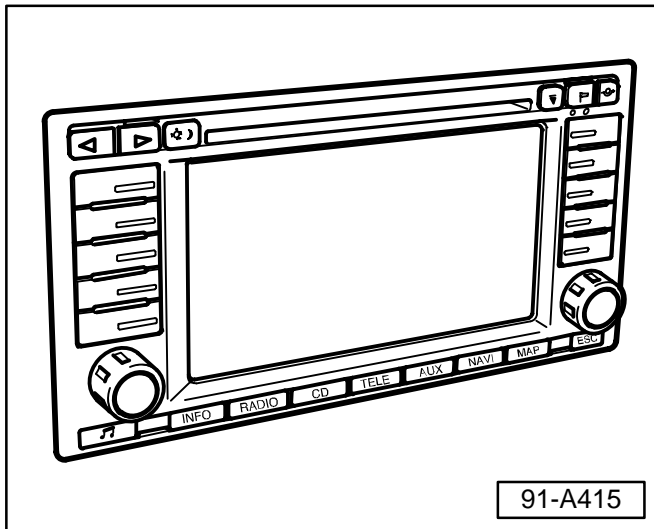
Radio system exhibits insufficient Bass (low frequency) output.

◀ On all Touareg's equipped with radio/navigation system (Sound II) built prior to VIN: 7L94D015720:

- Replace with new radio amplifier, Part No. 7L6 035 466. See Repair Manual, *Repair Group 91, Amplifier, Removing and Installing.*
