# Technical Bulletin

Subject: DVD Navigation, Update Programming

Number: 06-01

Model(s): Touareg

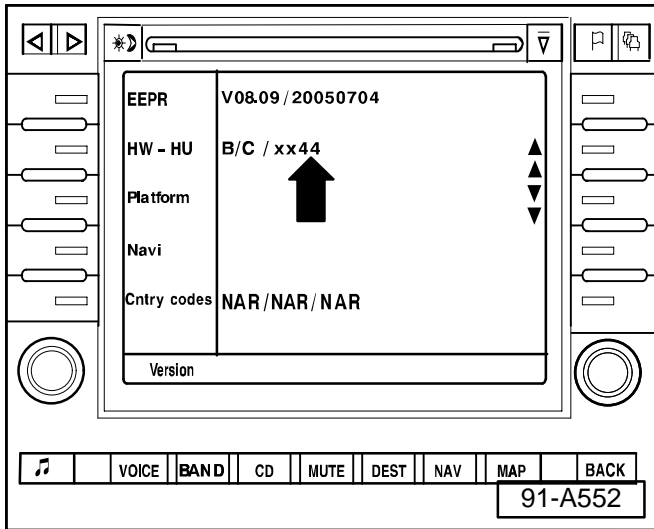
– Check four digit number (arrow):  
◆ Last two digits indicate software version.

If the last two digits read 47 or higher:

Update has been performed. Press “Back” twice to discontinue procedure. DO NOT complete the remainder of the Technical Bulletin.

If the last two digits read 46 or lower, continue to update flashing.
