# Technical Bulletin

### Customer States the Intermittent Wiper Function Operates Erratic on Vehicles With Rain Sensor

92 06 06 Oct. 20, 2006 2013173

Model(s)	Year	Eng. Code	Trans. Code	VIN Range From	VIN Range To
Touareg	2007	All	All	7L_7D000001	7L_7D034999

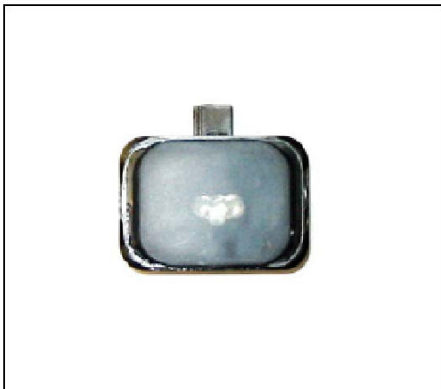
Intermittent wiper function operates erratic on vehicles with rain sensor - G213-. Wiper intermittent function delay time does not change when dial is changed. This condition may be present on early production rain sensors.

- Identify rain sensor 1K095559R/T (there is only one set of diodes in the center of the part that contacts the windshield).

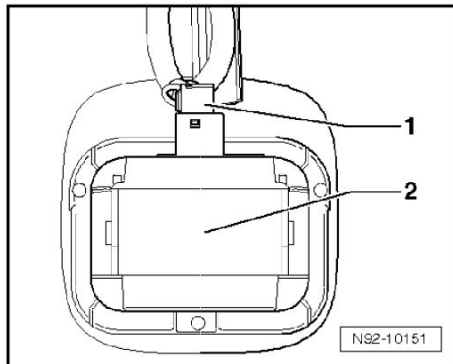
The improved rain sensor is identifiable by the white optical receptors - arrows-, or if view closely, the stacked diamond shape through the middle of the sensor.

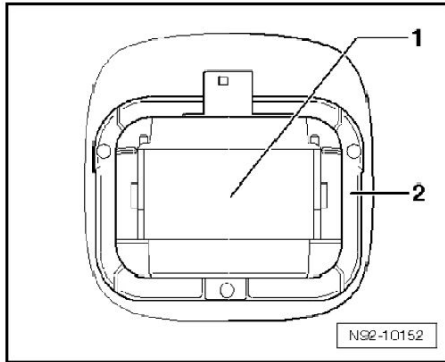
When removing, make sure to pry off complete Rain Sensor -G213- or Rain/Light Recognition Sensor -G397- and not only the upper casing of Rain Sensor -G213- or of Rain/Light Recognition Sensor -G397-.

Upper shell of sensor is easily detached and may break when removing (prying). Use care to ensure complete sensor is removed from frame.

- Using a screwdriver, pry Rain Sensor - G213- or Rain/Light Recognition Sensor - G397- -1- from bracket -2-.
