Technical Bulletin

Subject: **Tail Light Assembly, Difficult to Remove or Lens
Cracks During Removal**

Number: **05-01**

Model(s): **Touareg**

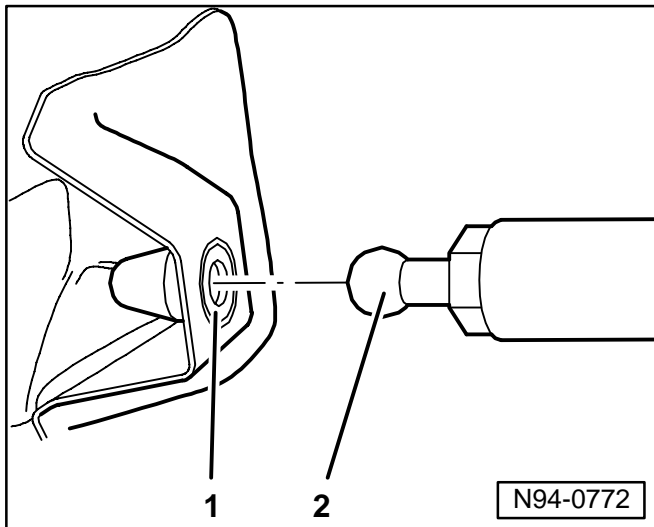
Tail light assembly is hard to remove or lens cracks during removal.

May be due to excessive retention force of the tail light retainer installed in the body.

- ◀ - Replace existing retainer -1- (white) with new improved retainer Part No: 7L6 905 229 (black).
- Reinstall Tail light assembly.
