## DIY Fix for "Loose Gas Cap" indicator aka code P0449 w/Pics

### DIY Fix for "Loose Gas Cap" indicator aka code P0449 w/Pics

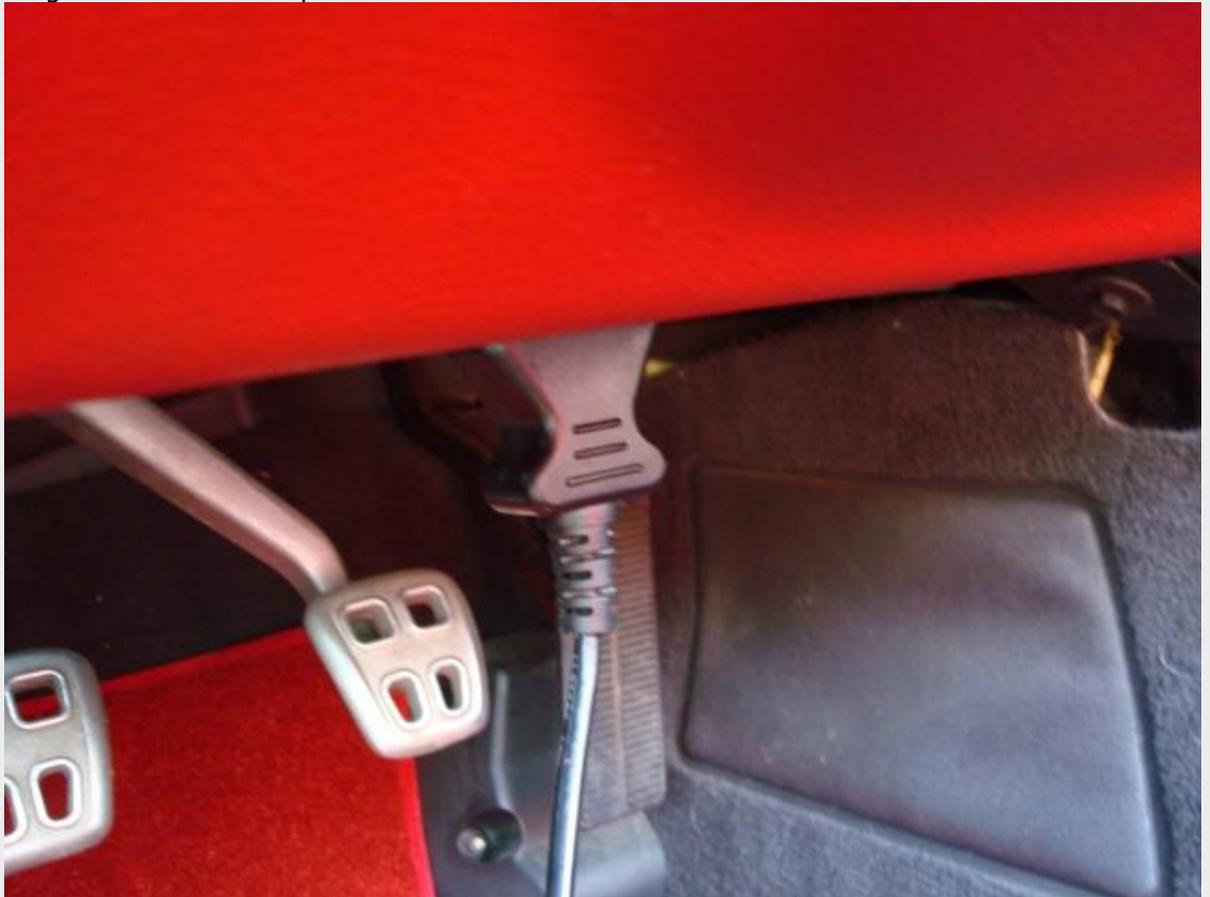
Plug it in the OBD adapter located under the driver's side dash.

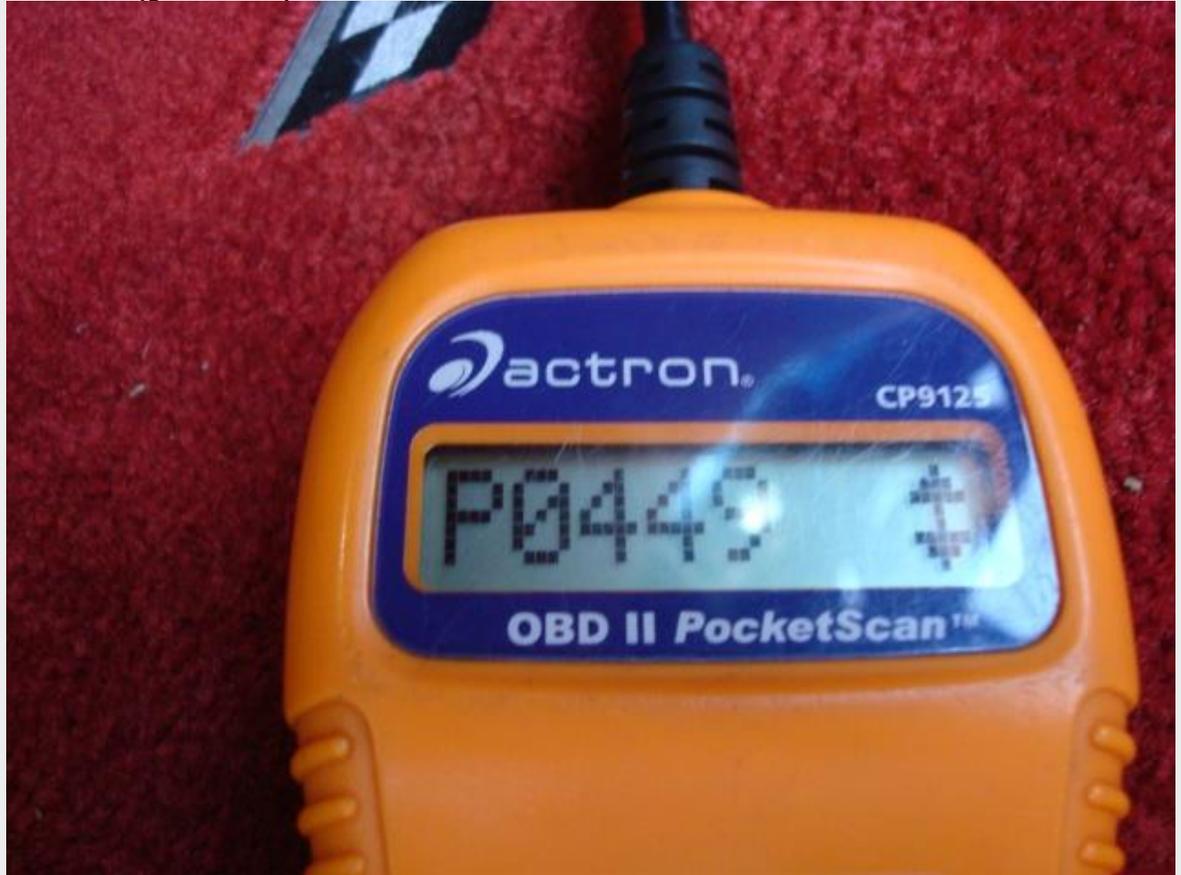
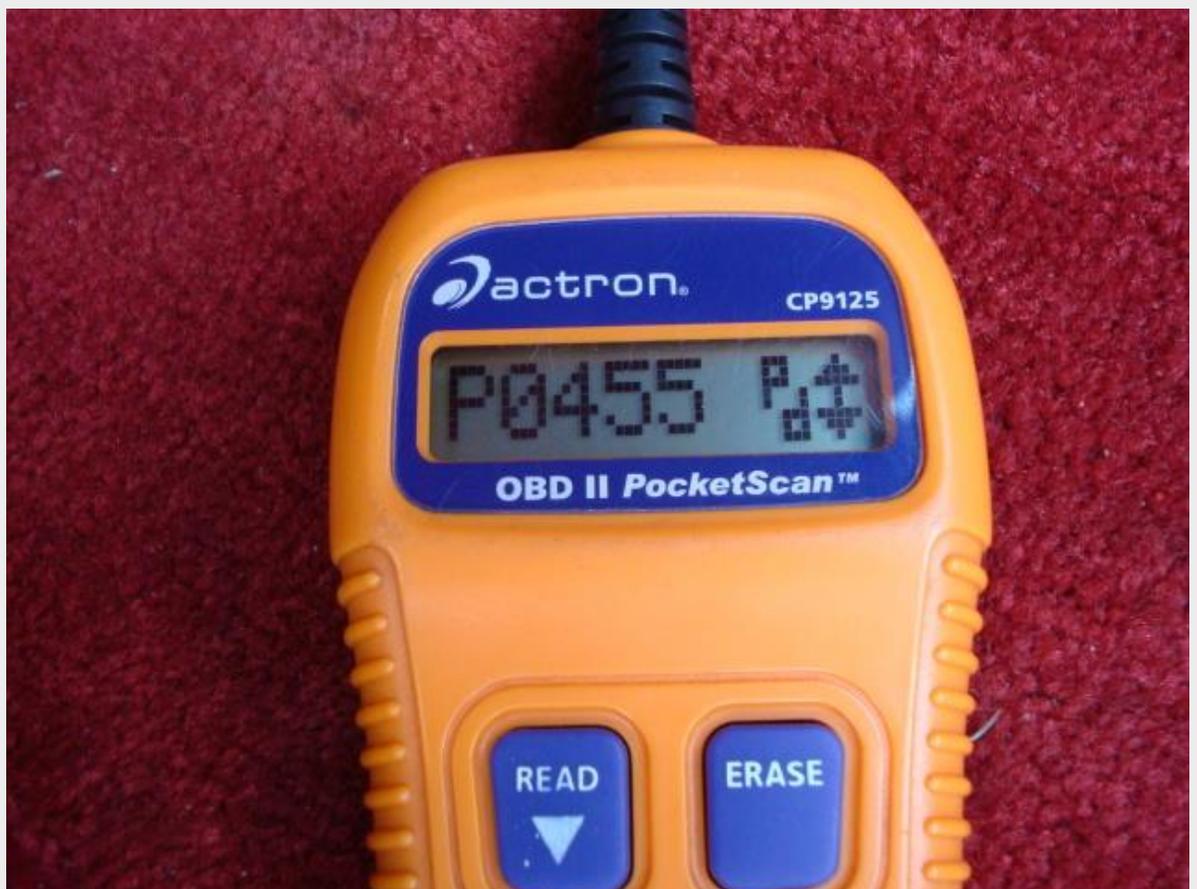
In my case I had a P0449 and a P0455. **P0449** Evaporative Emission Control System Vent Valve/Solenoid Circuit Malfunction and **P0455** Evaporative Emission Control System Leak Detected (gross leak)

I tried resetting my codes, but they would come back within seconds. The next step is purchase a new Fuel Vent Solenoid from your local dealer. In my case it was about \$25. GM also recommends an upgraded harness (\$30)...but it was not needed, so I will return it.

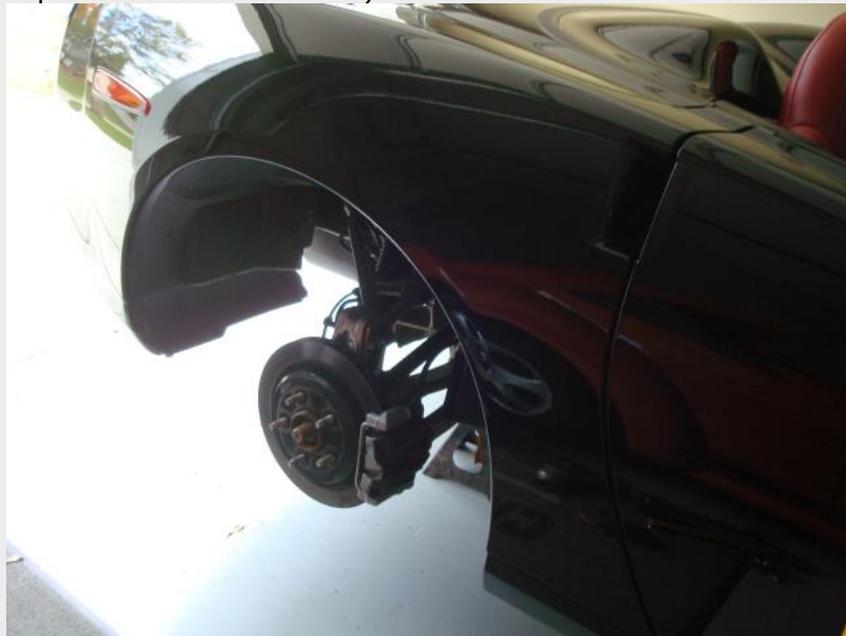
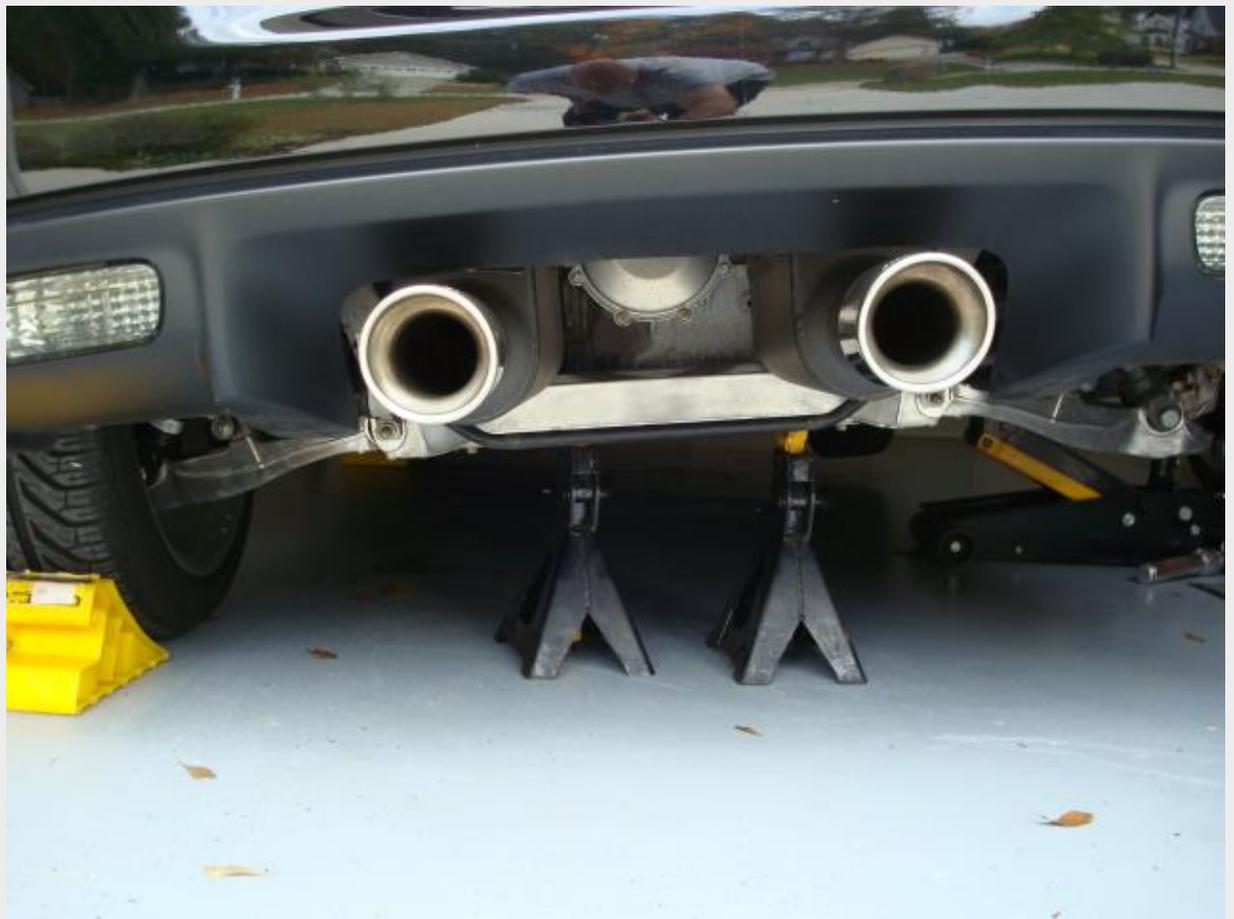
The Fuel Vent Solenoid is located on the passenger side tank near its top and is easy to get to. I removed my rear tire, jacked up the car, placed jack stands and chocks (I'm super cautious under a car).

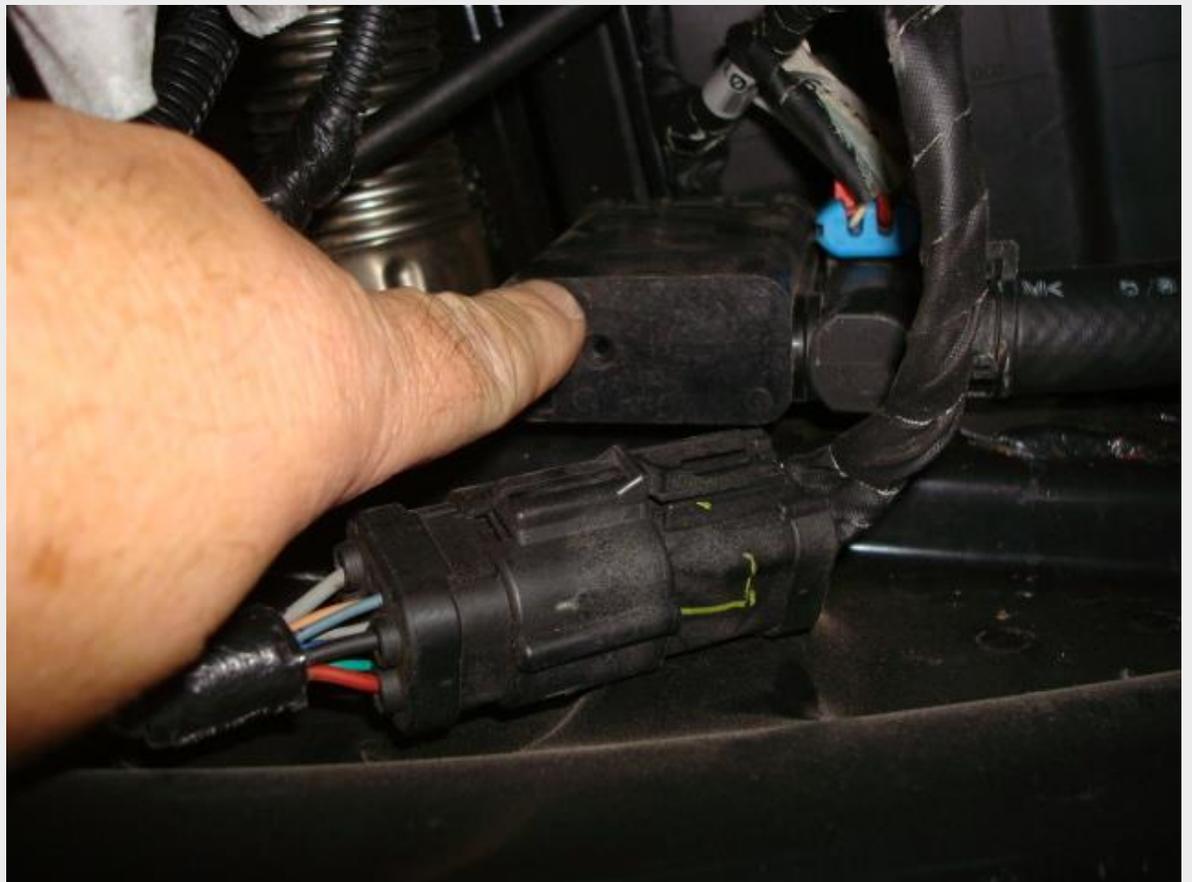
Once under the car this is what you will see, and I have my finger on the part:

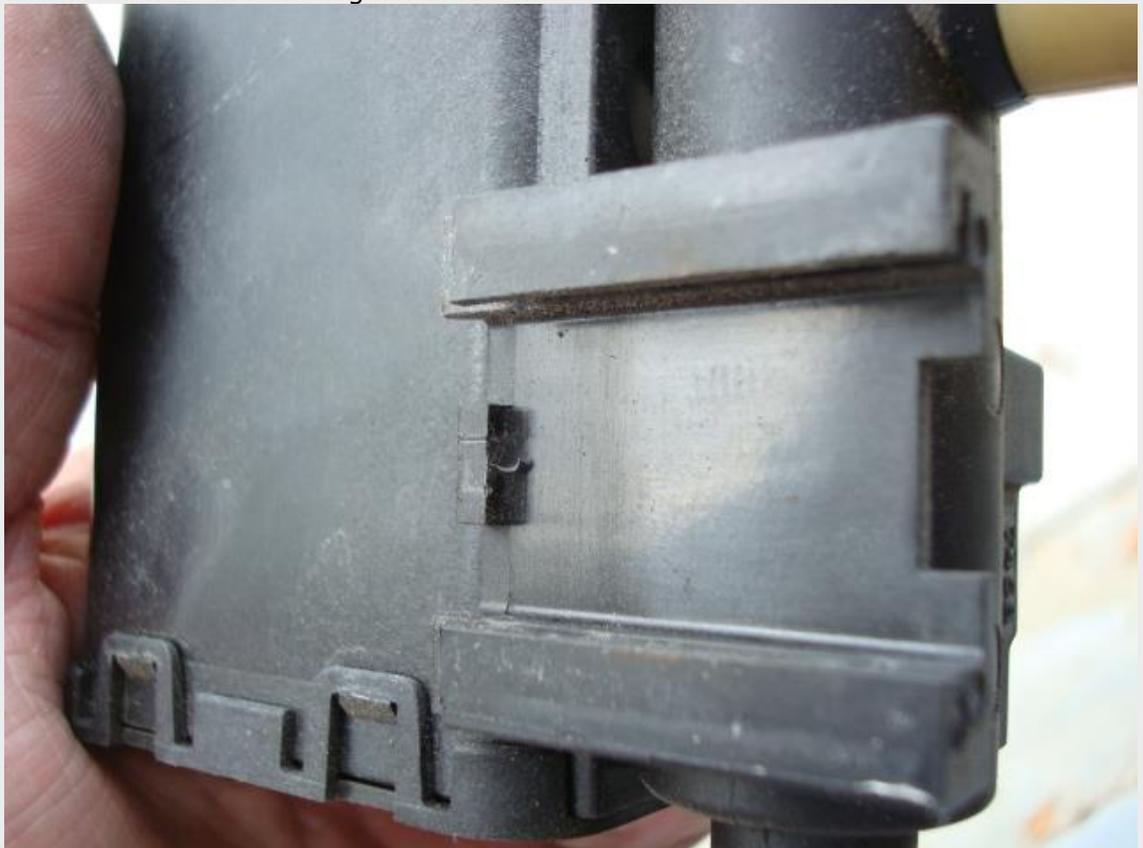
Slide the Vent Solenoid Assy off its bracket. Although it looks like it would slide towards the front of the car it does not. Simply lift the back of the assy high enough for the dog ear to clear the back of the bracket and slide toward the rear of the car. The pic below shows you how it mounts and the dog ear location.

Put the new Vent Solenoid Assy back on by placing it on the bracket and slide it towards the front of the car. You will hear it click in place. Plug the power plug back in and reconnect the hose.

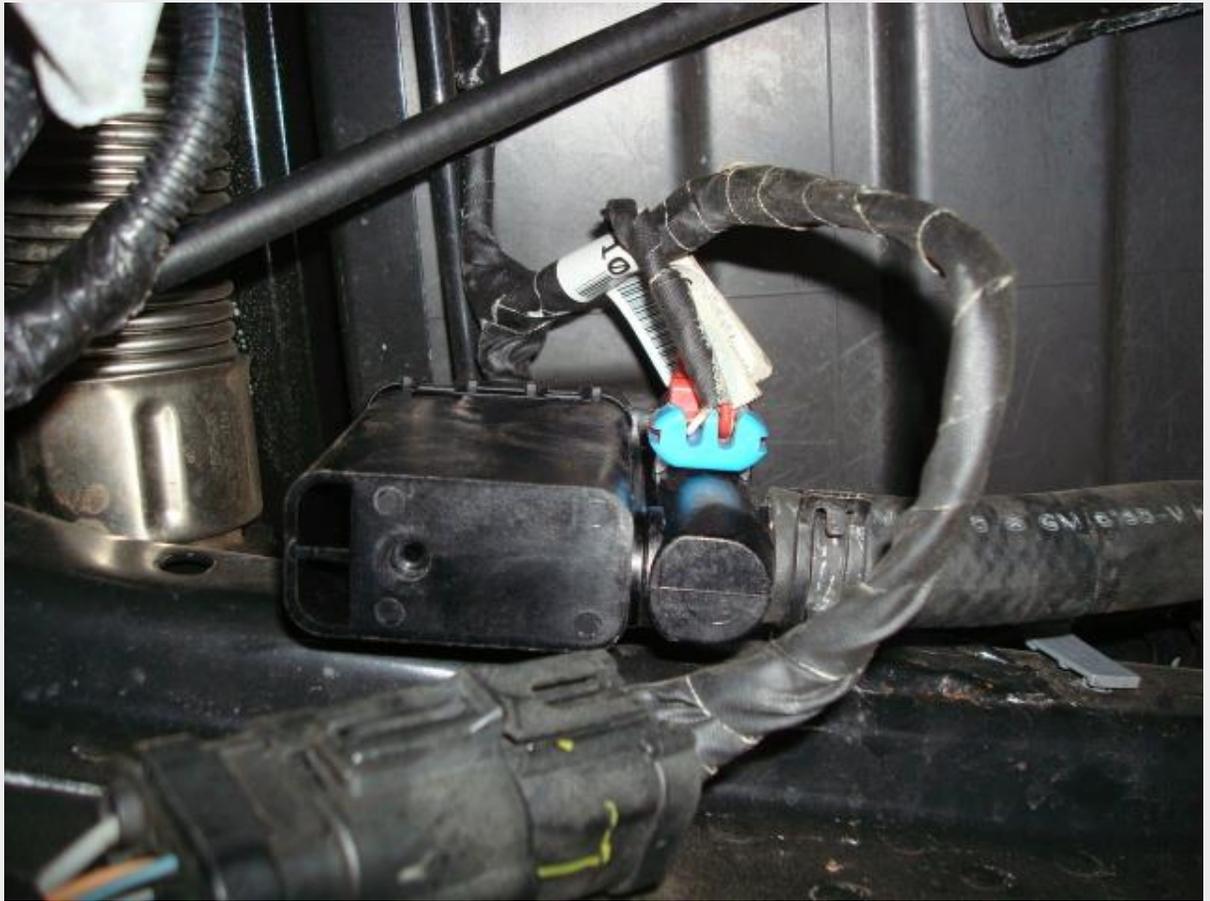
Here is the new one installed.

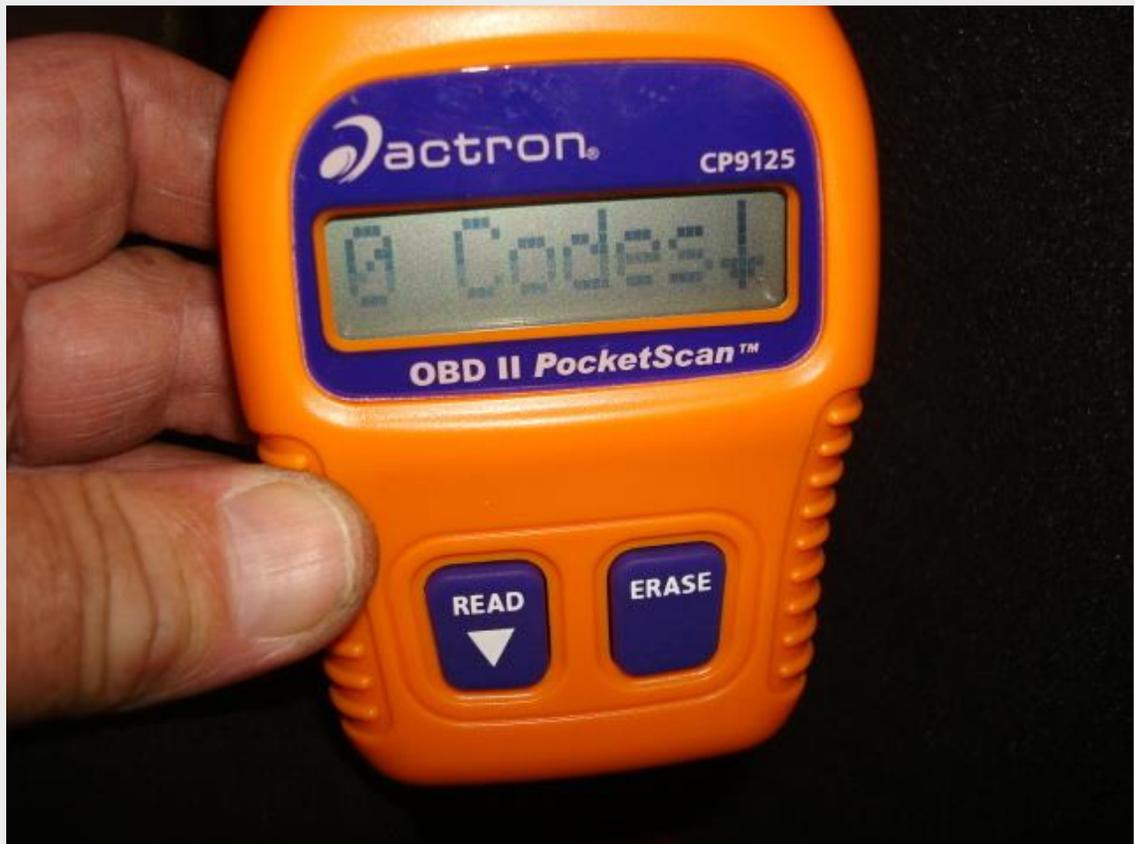
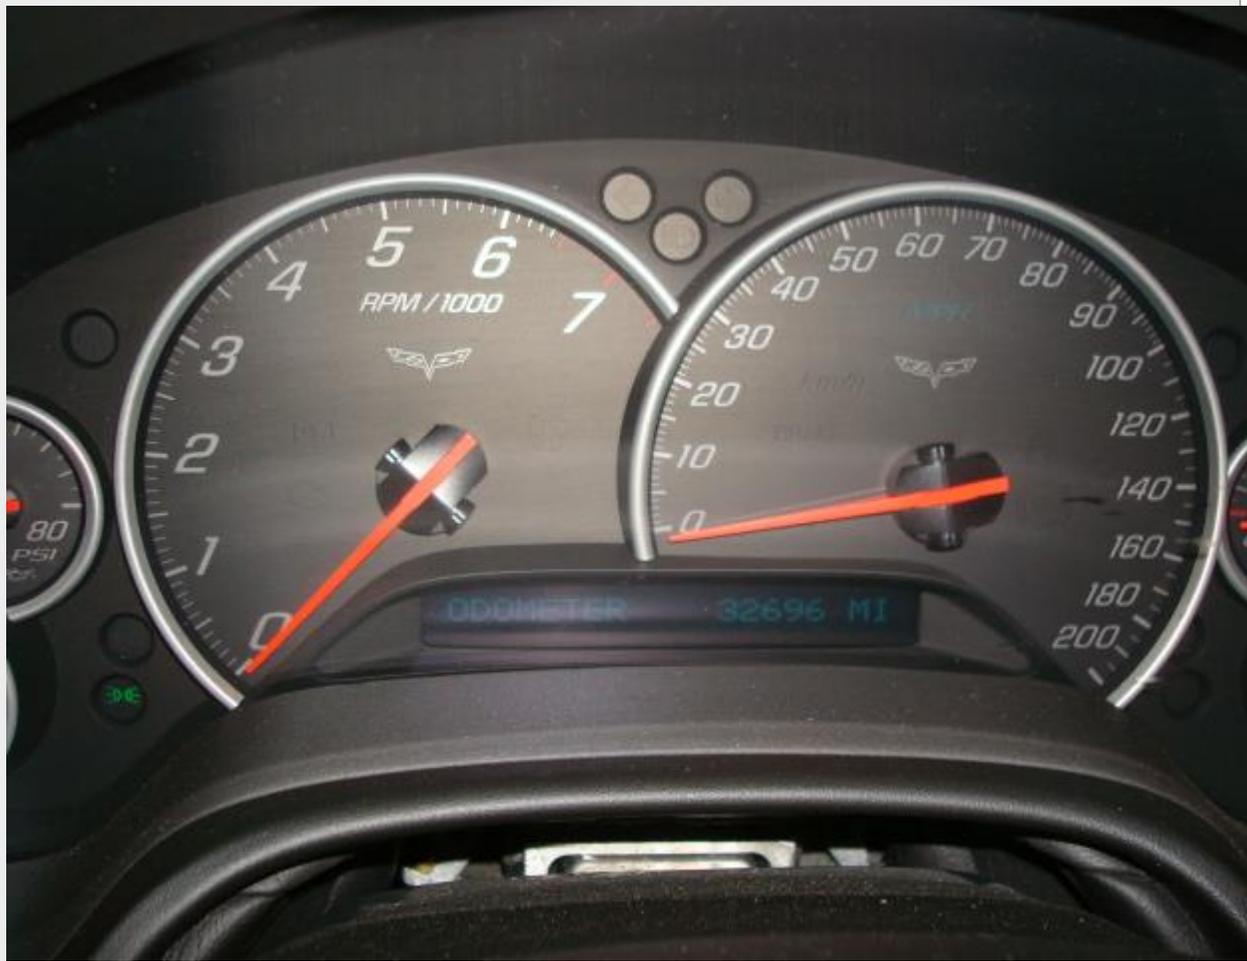
Now plug your code reader back in and scan for codes. If they come up hit erase. This is what you should now see on your code reader. No Codes and the DIC is clear with no check engine light or warnings.
