NUMBER: 23-038-18

Convertible Top Rubs On Rear of Headrest When Opening and Closing

This bulletin involves increasing the clearance between the seat back bar garnish and convertible top.

2017 (BA) FIAT 124 Spider (Convertible)

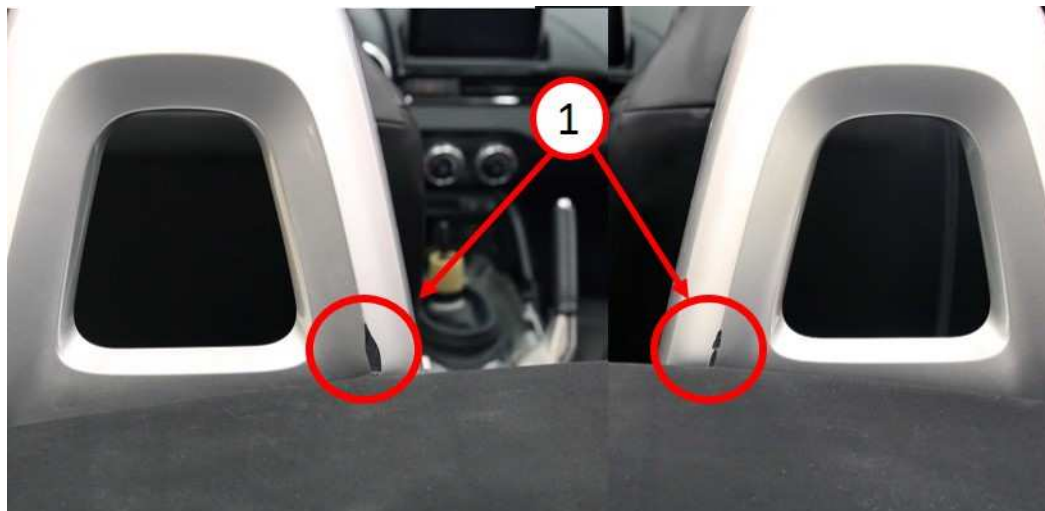
Fig. 1
Roll Bar Trim Panel Contact Area

The customer may notice scratches on the seat back bar garnish (REAR) by the convertible top making contact (Fig. 1).

1 - Headrest Cover Damage

NOTE: Due to assembly variations, the clearance between the seat back roll bar trim panel and the convertible top when being open is small on some vehicles and they interfere by vibration during vehicle driving.

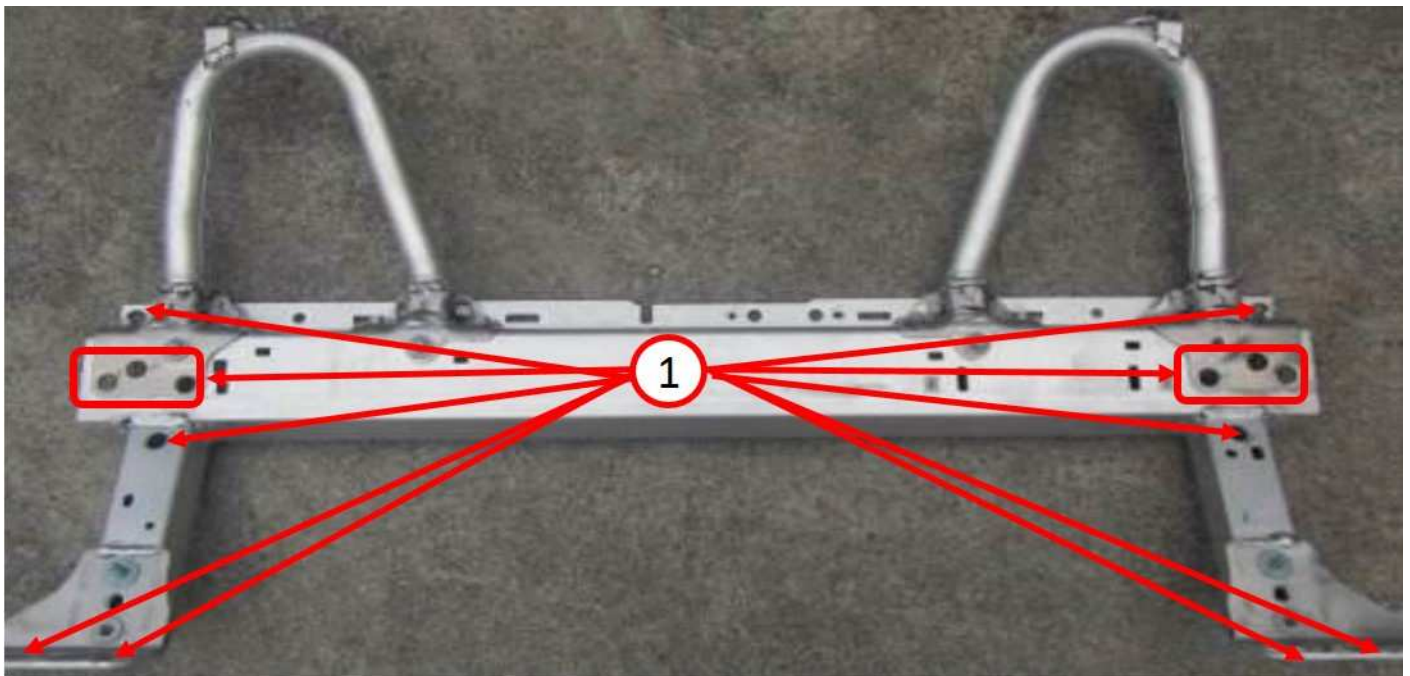
Fig. 2

Seat Back Crossmember Assembly Bolt Locations

1 - Bolt Locations

1. Remove the wind stop from vehicle. Refer to the detailed service procedures available in DealerCONNECT> TechCONNECT under: Service Info>23 - Body/Interior/Stop, Wind/Removal.
2. Remove the roll bar trim panel from vehicle. Refer to the detailed service procedures available in DealerCONNECT> TechCONNECT under: Service Info>23 - Body/Interior/Panel, Roll Bar Trim/Removal.
3. Remove the seat belt retractor installation bolts and set the seat belt retractor aside.
4. Remove the seat back crossmember assembly (Fig. 2) .

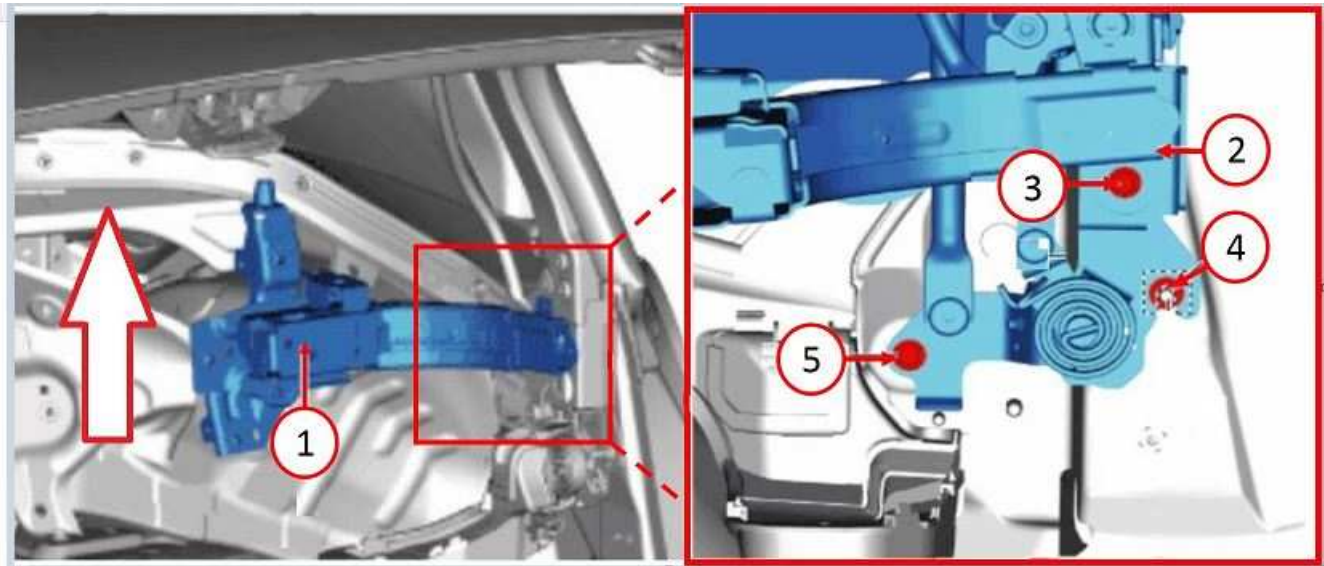
Fig. 3
Link Bracket and Fastener Locations

- 1 - Link Bracket
- 2 - Link Bracket
- 3 - Bolt
- 4 - Stud-bolt and Nut
- 5 - Bolt

5. Adjust the position of the link bracket. (For both left and right sides) (Fig. 3) .
6. Loosen the two bolts and nut.

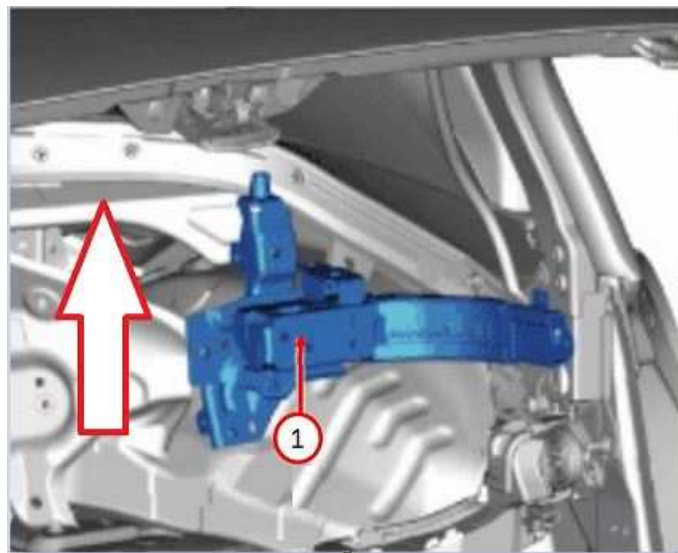
Fig. 4
Lift Up the Link Bracket

- 1 - Link Bracket

7. Lift up the link bracket (Fig. 4) .

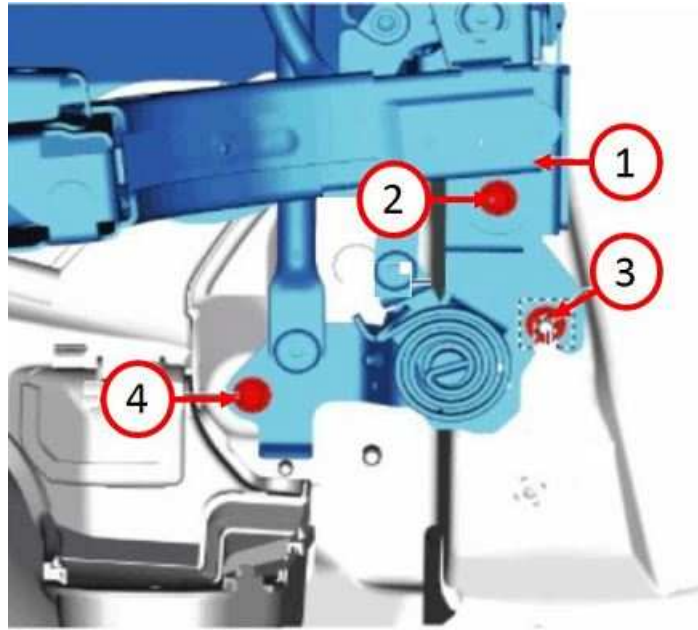
Fig. 5
Link Bracket Fastener Location

- 1 - Link Bracket
2 - Bolt
3 - Bolt Stud and Nut
4 - Bolt
-

8. Tighten the two bolts and bolt stud nut of the link bracket to 19-25 N·m (15-18 ft lbs) (Fig. 5) .

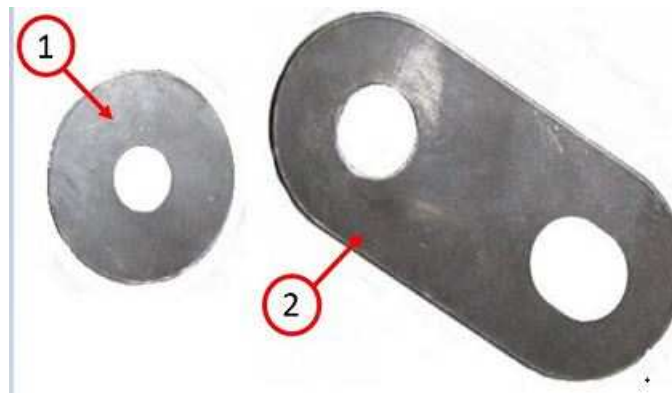
Fig. 6
Washers

- 1 - Washer "A"
2 - Washer "B"
-

9. Attach the washers to the link bracket.
10. Apply an appropriate adhesive to the washers (Fig. 6) as shown in the illustrations to temporarily fix the washers on the link bracket.

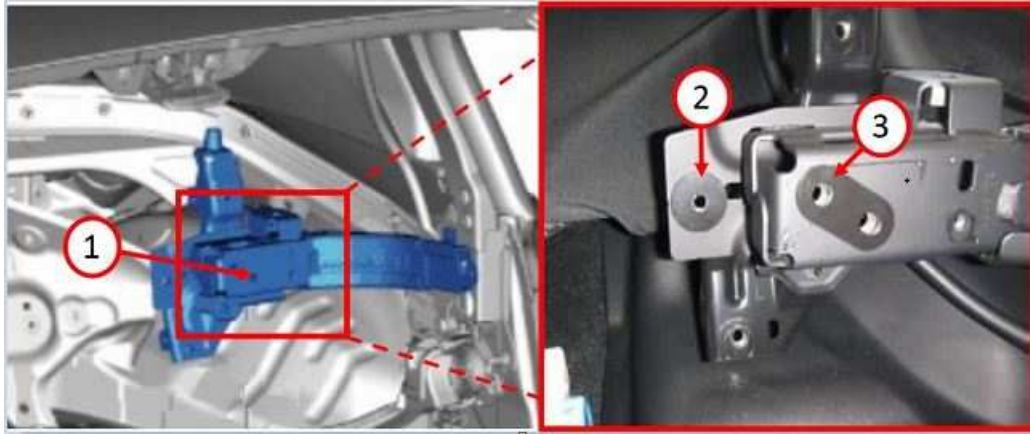
Fig. 7
Washer Locations

- 1 - Link Bracket
- 2 - Washer "A"
- 3 - Washer "B"

11. Affix the washers to the surface of the link bracket by using adhesive (Fig. 7) .

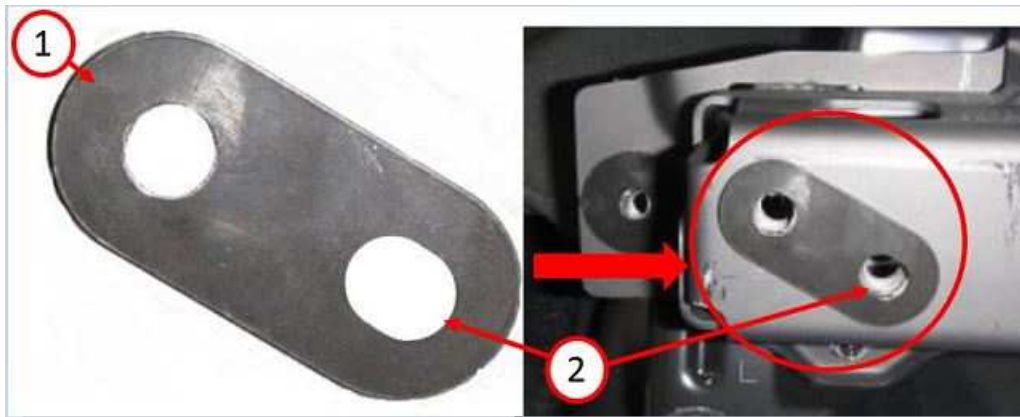
Fig. 8
Install Washer "B"

- 1 - Washer "B"
- 2 - Ellipsoid Hole

NOTE: Install the washer B with the ellipsoid hole placing as shown in the illustration (Fig. 8) .

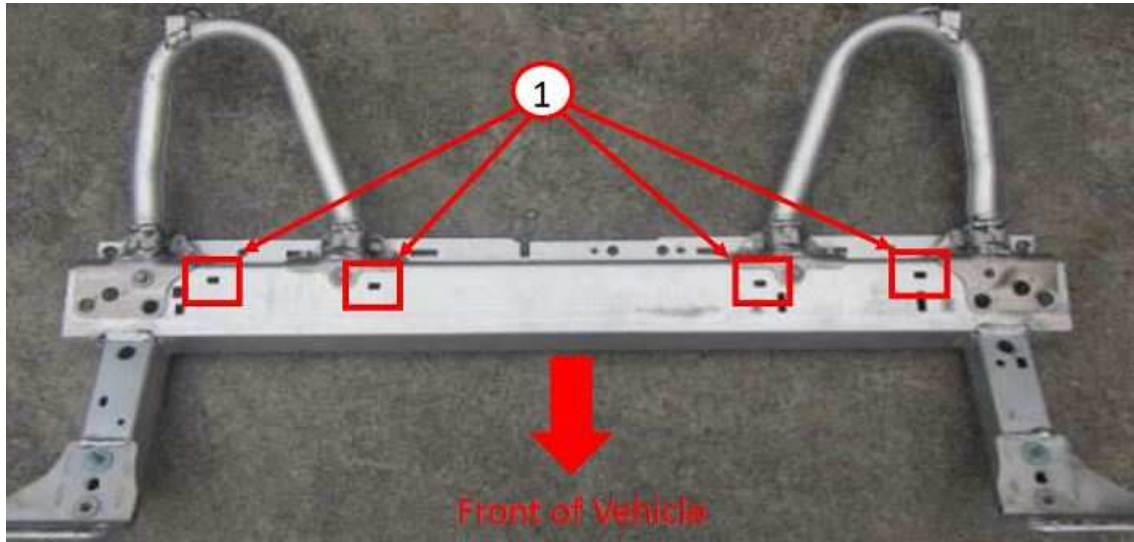
Fig. 9
Seat Back Crossmember

NOTE: When removing the metal fasteners of the back trim from the square holes of the seat back crossmember, the holes may be damaged causing the noise due to loose fit of the fasteners (Fig. 9) .

1 - Square Holes

12. Attach pieces of fabric sheet to the four square holes of the seat back crossmember to prevent creak noise generating.

13. Select a 0.25 mm (1/10 in) thickness fabric sheet from “Repair Kit” (P/N 68444671AA) and cut the sheet into 8 equal pieces of 15 mm (5/8 in) x 10 mm (3/8 in) size square.
14. Clean and de-grease around the four square holes of the seat back crossmember as shown in (Fig. 9) .
15. Attach the eight pieces of fabric sheet to the four square holes of the seat back crossmember (Fig. 10) .

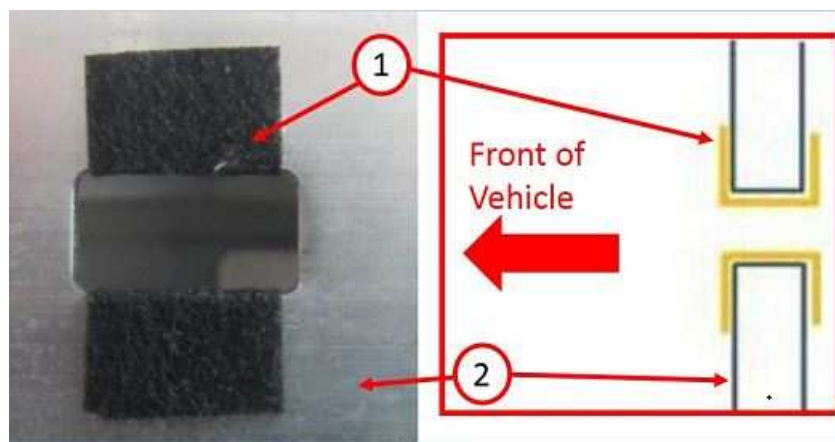
Fig. 10
Fabric Tape Application

1 - Felt Tape
2 - Seat Back Crossmember

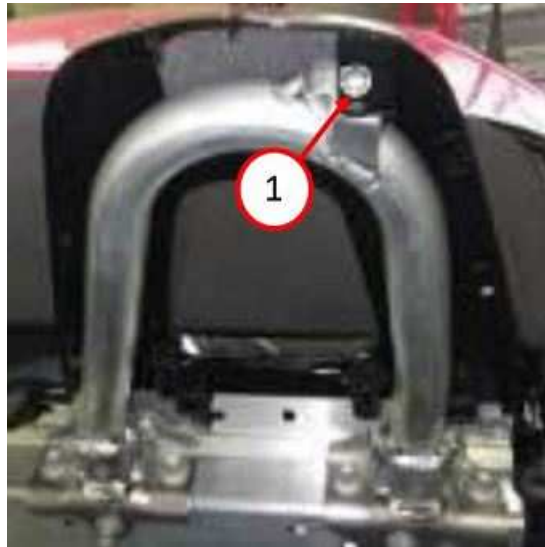
Fig. 11
Seat Back Roll Bar Screw Location

1 - Seat Back Roll Bar Screw

16. Install the seat back crossmember assembly tighten the bolts to 19-25 N·m (15-18 ft lbs).
17. Install the seat back bar garnish (Rear) while twisting the garnish so that the garnish can be kept closer to the seat back bar and away from the convertible top. (For both left and right sides)
18. Loosen the screw of the seat back roll bar trim panel (Rear) (Fig. 11) .
