R32: Early model radiator hose issue

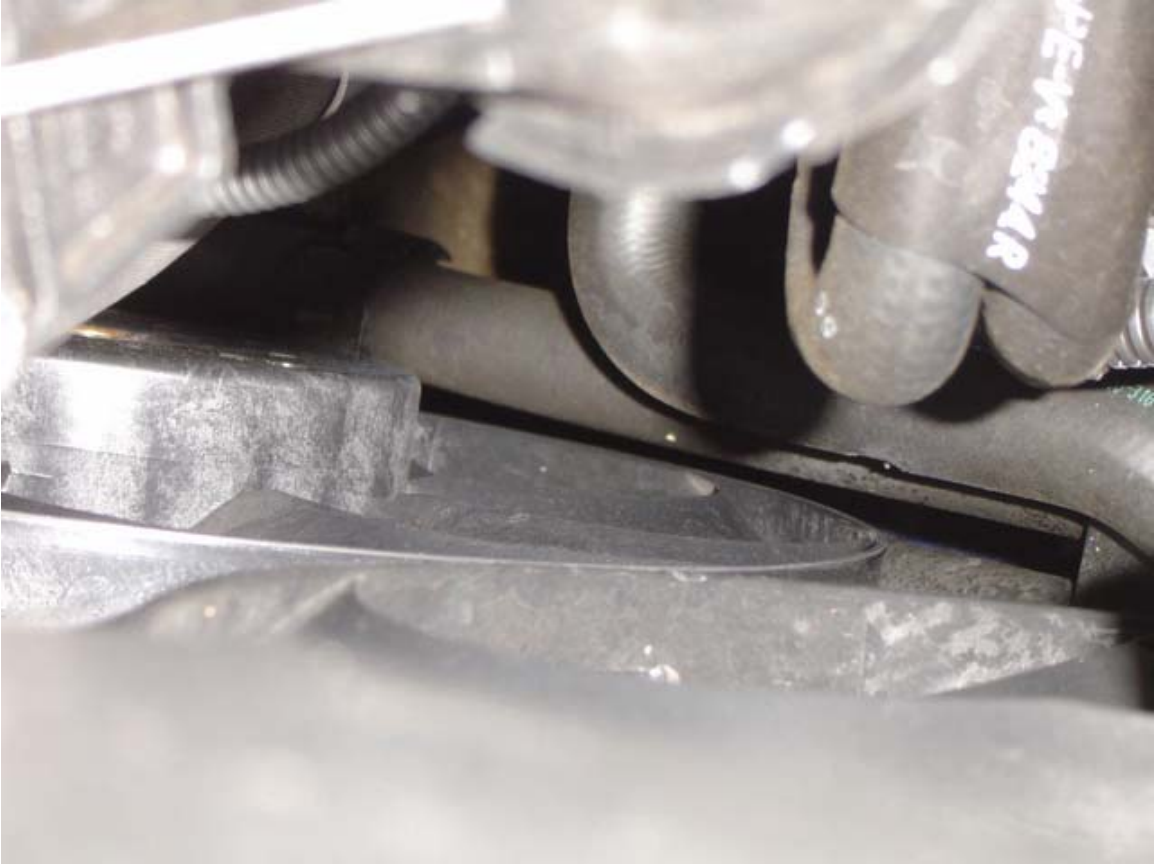
Old Hose (See rub mark on top hose)

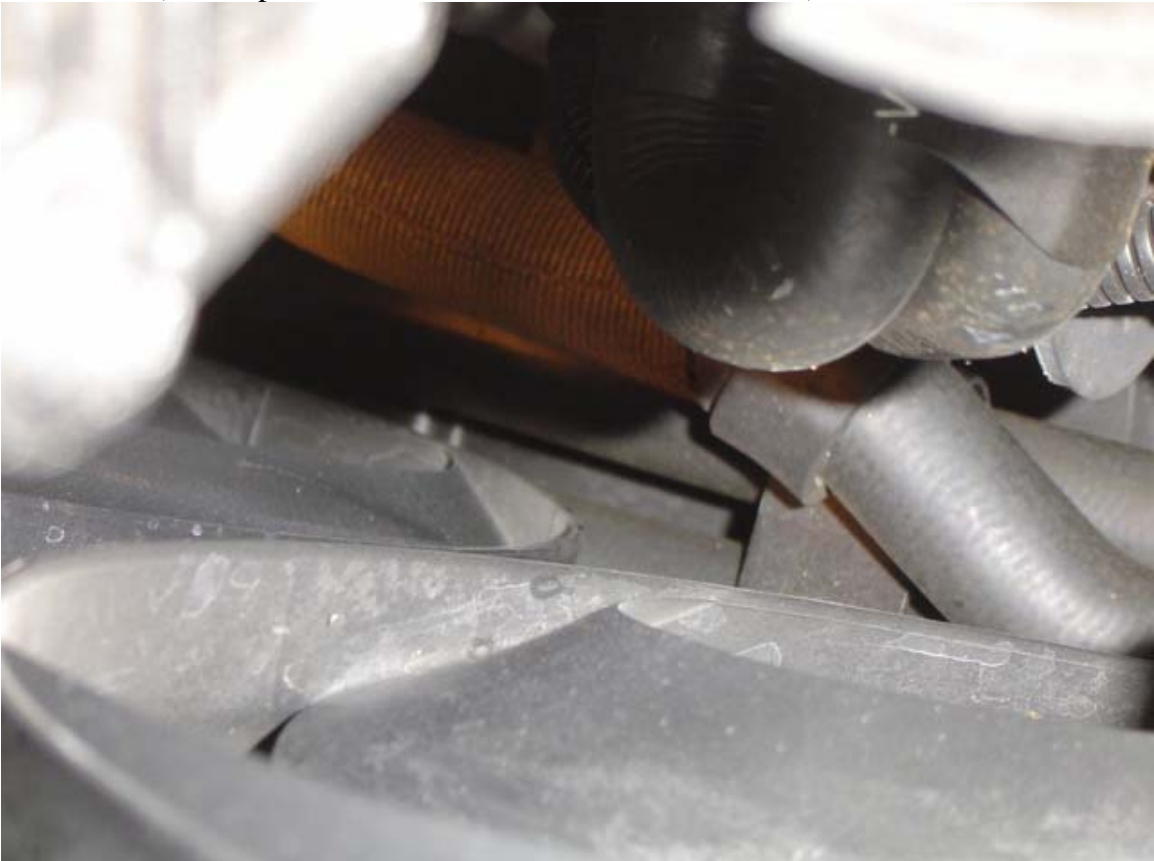
New Hose (Notice protective sleeve and rubber reinforcement) VW P/N 1J0 121 096 CJ
