# Compliance Recall Circular

**Code: UY**

**Subject: 2004-2005 Model Year Touareg Vehicles  
Inspect Rear Outboard Seat Belts and, If Necessary,  
Install Seat Belt Shortening Clips**

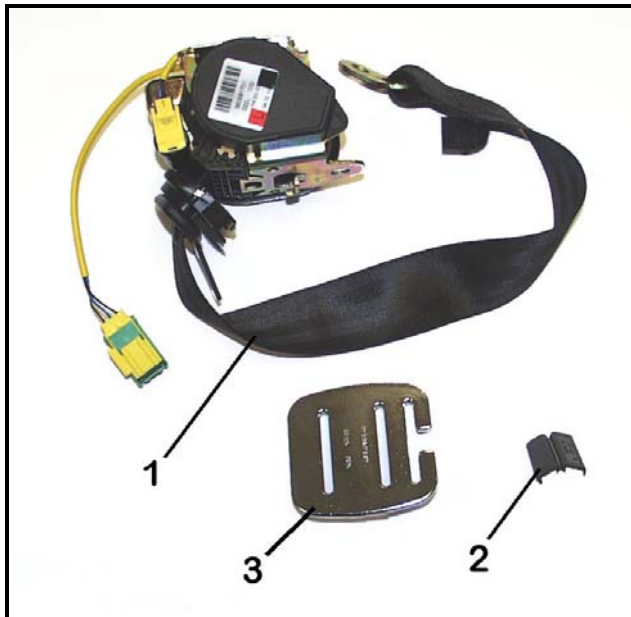
- ⇐ 7L0 857 805A/806A – Seat belt -1-
- ⇐ 7L0 857 837 - Bracket -3- with locking clamp -2-

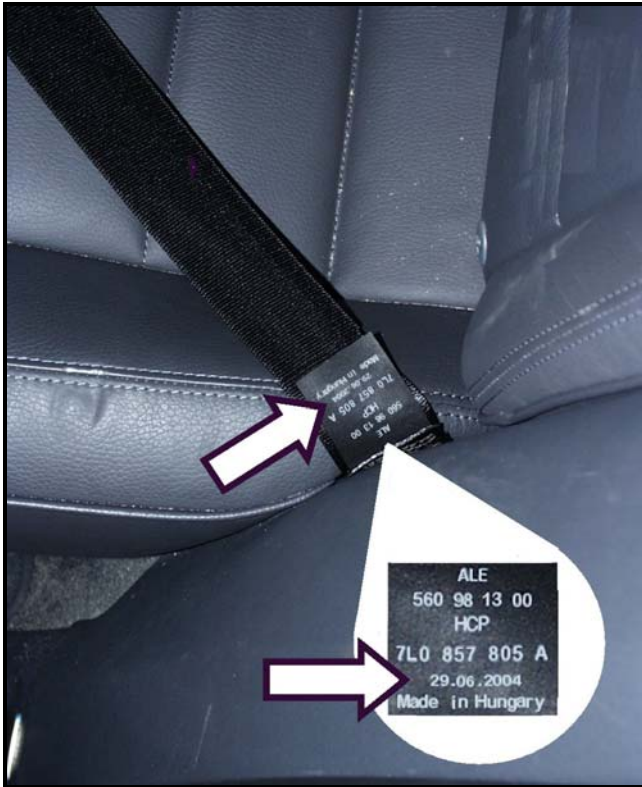
### Section A – Check Rear Seat Belt Identification Label

- Open both rear doors
- ⇐ Illustration is showing left rear seat belt
- ⇐ Check the date -arrow- on the left and right outer rear seat belt labels;

Note: The date is shown in day, month year (dd.mm.yyyy) format

- If the date is 07.08.2004 (**7 August 2004**) or later on the left **and** right seat belt label, no further work is required
- If the date is earlier than 07.08.2004 on only one of the seat belt labels, proceed to **Section B**

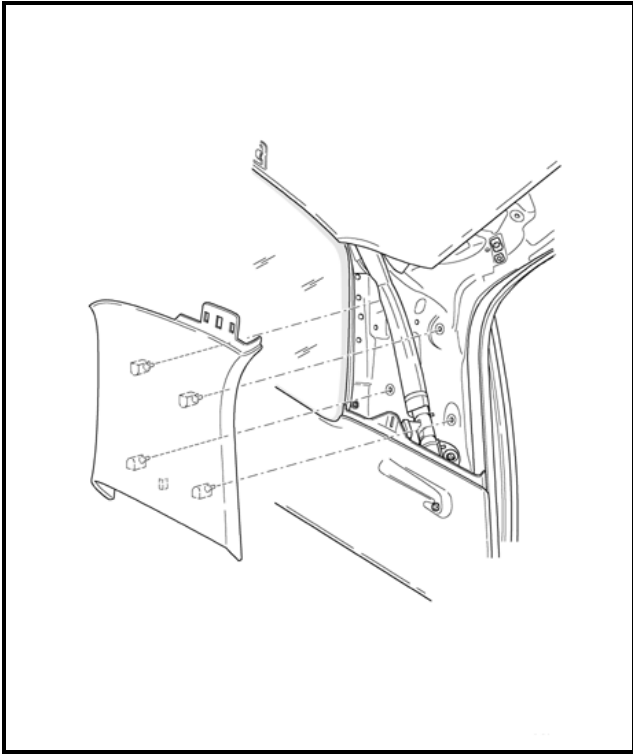
⇐ Pull D-pillar trim out of mountings in body and door seal molding

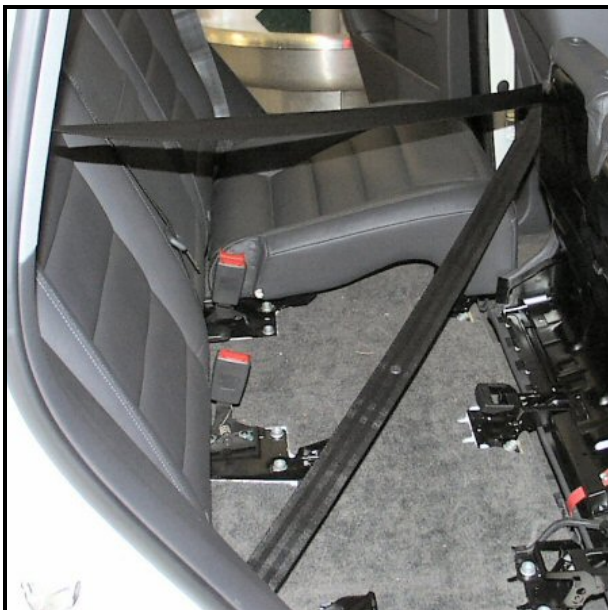
⇐ Tilt the rear seat bottom forward and pull the rear seat belt out approximately 90 to 100 cm (35 to 40 in.)

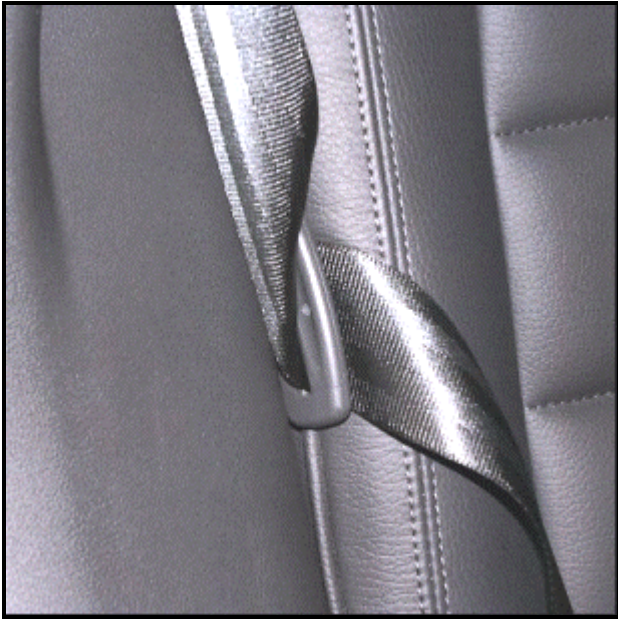
- ⇐ While holding the seat belt pulled out, slide the seat belt tongue along the belt and carefully wedge it between the rear seat back and the C-pillar trim to prevent the seat belt from retracting

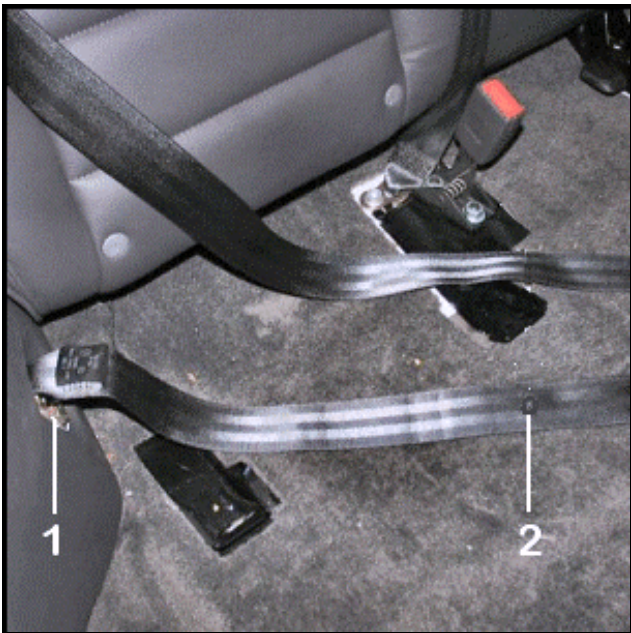
- ⇐ Lay the seat belt flat on the vehicle floor without twisting the belt
- ⇐ Locate the mid-point approximately halfway between the seat belt anchor point -1- and the latch stop button -2-

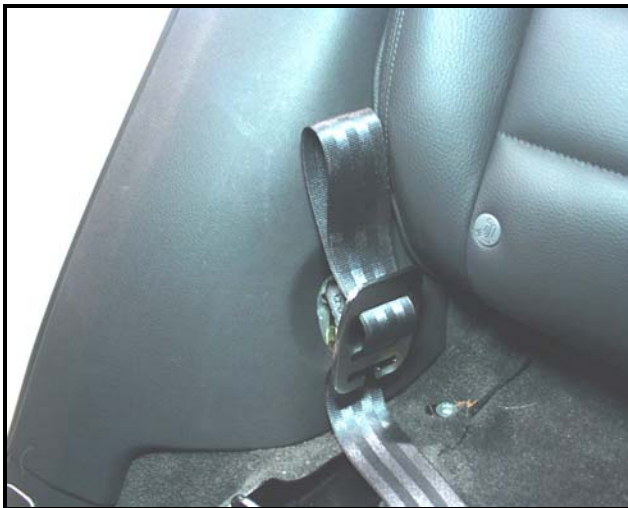
⇐ Fold mid-point of seat belt down and insert into outer slot of bracket

- Pull mid-point of seat belt completely through outer slot and remove any slack while making certain the bracket is still tight against the latch stop button and seat belt anchor point

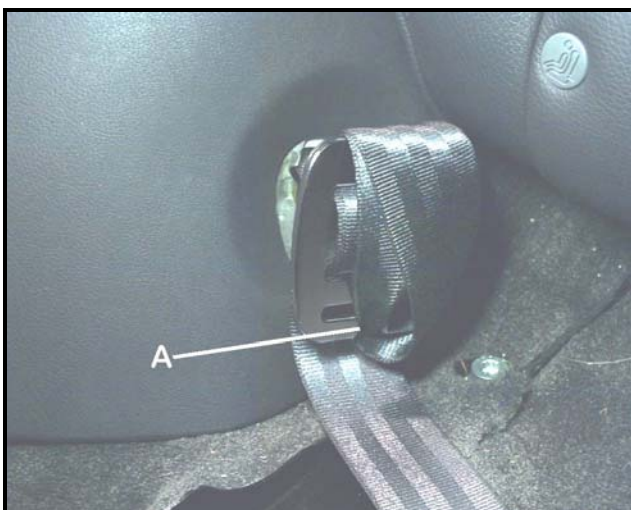
⇐ Fold the seat belt over the top of the bracket and insert seat belt through the cut -A- and into the slot then spread seat belt completely across the slot and over outer edge

- Make certain the seat belt is centered over the slot and outer edge

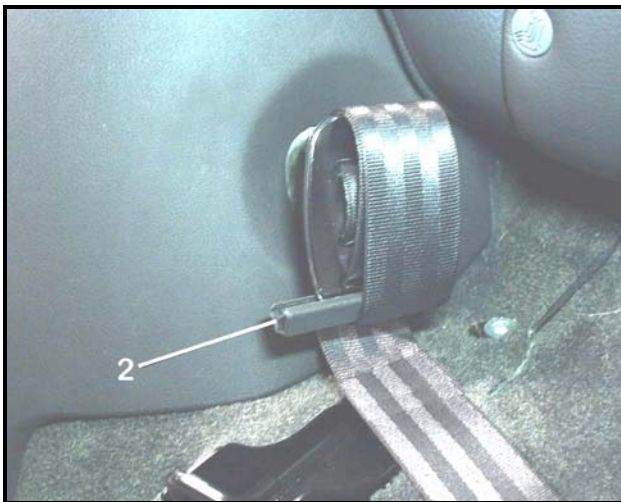
⇐ Slide the locking clamp -2- across the bracket between the seat belt and the cut slot end

- Squeeze the locking clamp together with your fingers until it locks together over the cut slot end
