Technical Bulletin

Subject: **Radio, Tone, Balance or Fader Knobs Broken or Loose** Group: **91**

Number: **03-02**

Model(s): **All with Panasonic Premium
VI Radio**

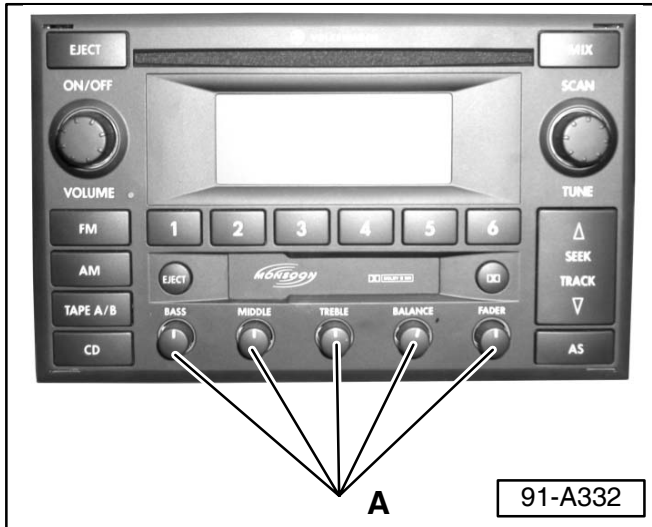
Panasonic Premium VI (Radio/CD/Cassette Player) tone/balance/fader knobs broken or loose.

- ◀ – Replace ALL five knobs -A- with 5 knobs from kit Part No: ZVW 828 002A.
- Discard knobs removed from radio.

To prevent repeat repair to a different knob at a later date. It is important to install ALL 5 knobs from the kit.
