Technical Bulletin

Subject: **Rear Hatch Glass, Open Warning Displayed In Multi-Function Display**

Number: **05-05**

Model(s): **Touareg**

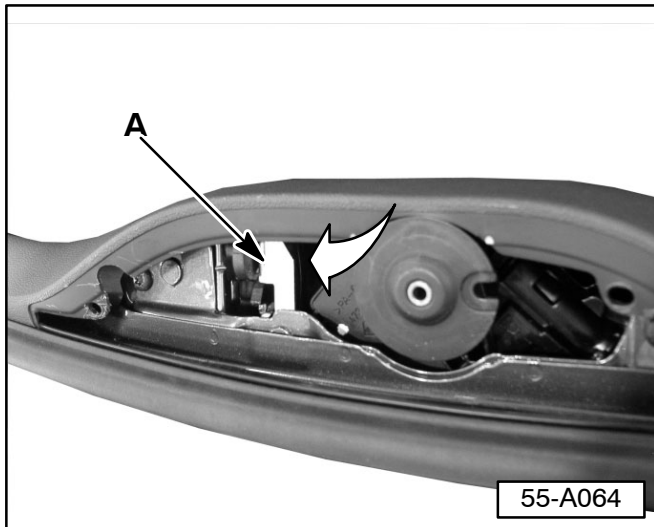
- Open rear window.
- Remove rear wiper motor trim cover.
- ◀ - Check Part No. -white arrow- on side of rear hatch glass latch -A-.

If rear hatch glass latch Part No. is 7L0 827 506D:

- No Service Action Required. Do Not complete this Technical Bulletin.

If rear hatch glass latch Part No. is 7L0 827 506C:

- Replace rear hatch glass latch. See Repair Manual, *Repair Group 55, Hinged Window Lock, Removing and Installing.*
