Technical Bulletin

Subject: Exterior Rear View Mirror, Wind Noise Above 50 MPH

Number: 05-01

Model(s): Touareg

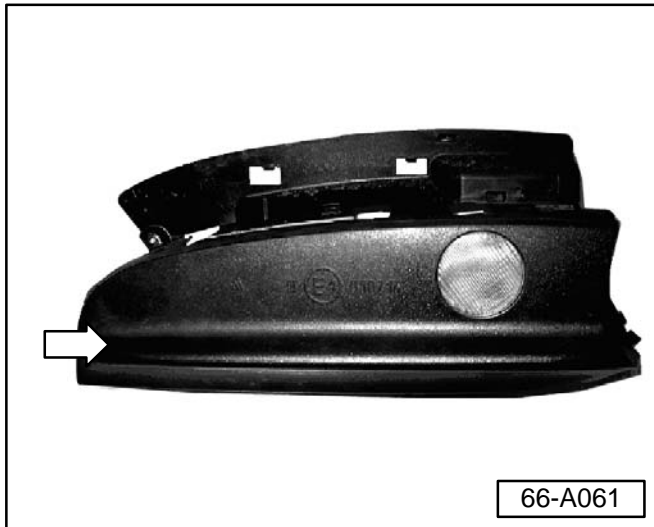
◀ The improved housing trim has a spoiler added to the trim surface facing down when installed.

Install new left and right lower mirror housing trims.
