# Technical Bulletin

Subject: **Rear Upper Seat Cover Makes Contact with Lower Seat Frame** Group: **72**

Number: **05-04**

Model(s): **Touareg**

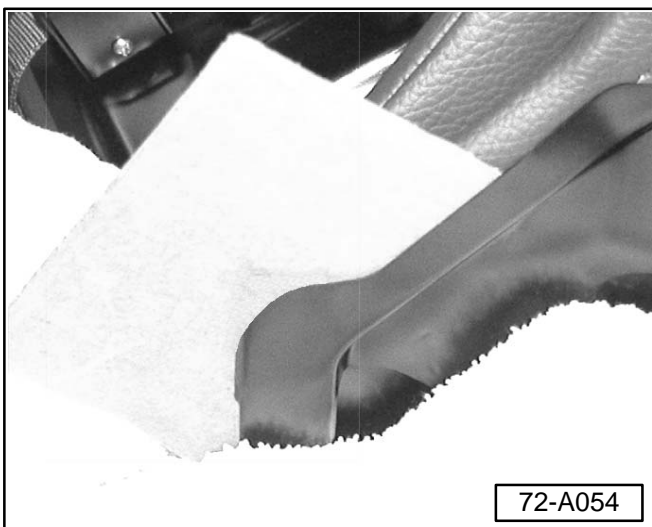
- Allow trimmed area to cool.

- Place a piece of paper over repaired area and fold seat back down into storage position.
- Ensure that seat back stop is engaged into lower seat frame rest.
- Apply slight pressure to seat back corner above repaired area when in the down position and lightly pull the paper away from repair area.
