Technical Bulletin

Subject: **Airbag Monitoring Light ON, Passenger Occupant Detection System, DTC 02511 014 Stored in Memory**

Number: **05-07**

Date: **May. 23, 2005**

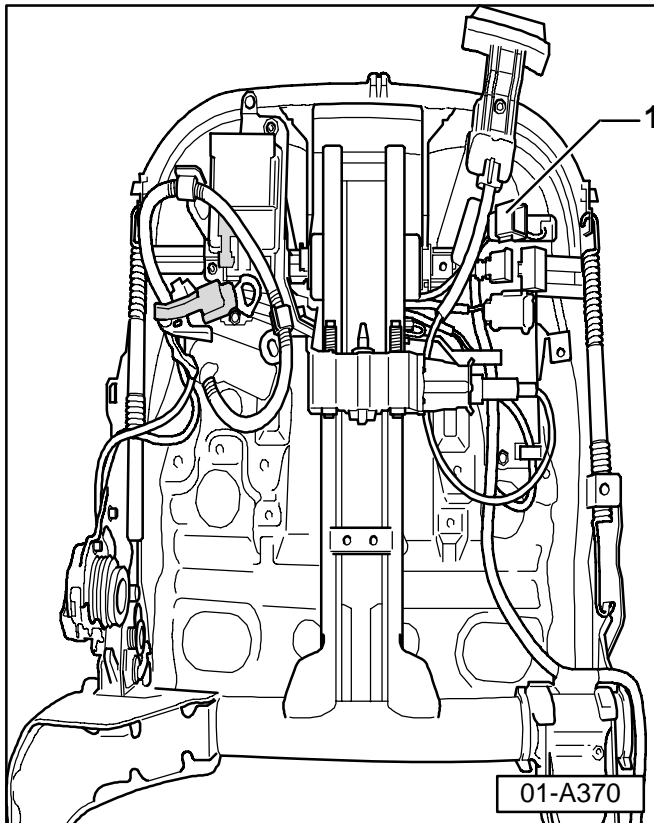
- Connect the VAS 5052 tester to the vehicle.
- Verify that the airbag indicator light is illuminated and that code "02511 014"- Seat Occupant Recognition Control Module Faulty is stored in Air Bag -15-.
- Turn the ignition OFF.
- Connect VAS tester serial port RS-232 and cable VAS 6103/2 with Cable VAS 6103.

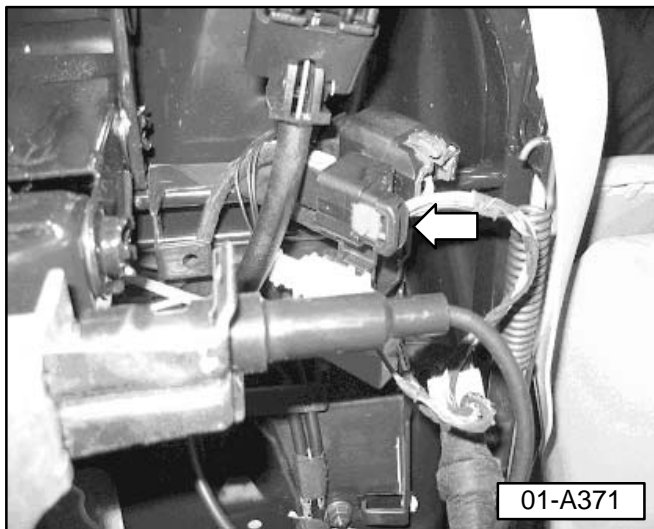
- Disconnect black Seat Occupant Recognition Module harness connector from bracket.
