Removing ([Refitting](#))

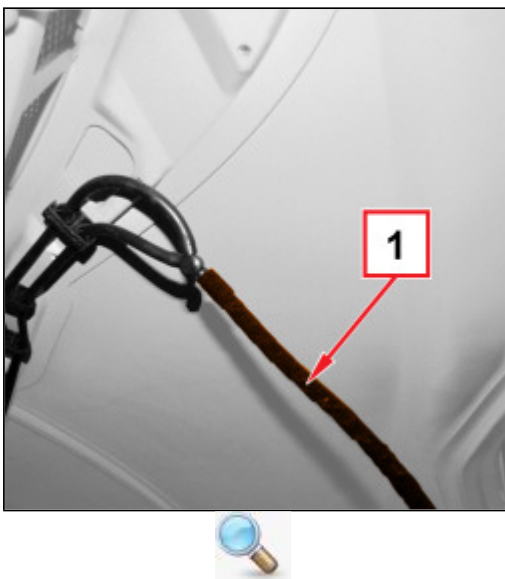
1. Raise the bonnet as necessary, and disconnect the windscreen washer fluid delivery pipe.
