Subject: Trailer Lights Inoperative, Update Programming

(Flashing) Trailer Control Module

Model(s): Touareg with Trailer Towing

Number: 05-12

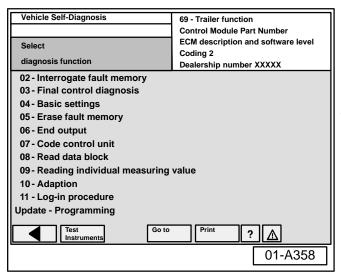
Once ALL fault memories have been erased:

- Install "Update Programming" (flashing) CD in diagnostic tool.
- Select vehicle system "69-Trailer function".
- Select "Update Programming" option at bottom of screen.

Vehicle Self-Diagnosis	69 - Trailer function	
Update - Programming	Control Module Part Number	
	Ctrl. Mod. description / software level	
	Coding XXXXX	
Programming can be carried out.	Dealership number XXXXX	
WARNING!		
The programme version stored in the control unit will be erased		
It will be programmed with the new version XXXX		
The erasing programming process will last roughly XX minutes		
The part number in the control unit identification may change.		
Vehicle specific data (coding, adaptation etc.) might be lost. It must		
be checked after successful programming		
After the continue button has been pressed the process cannot be cancelled.		
IMPORTANT PLEASE NOTE:		
Switching ignition off or disconnecting the diagnostic connector		
during programming may completely destroy the control module!		
Test Go to	Print Colon	
Instruments		
_	01-A359	
	01 A333

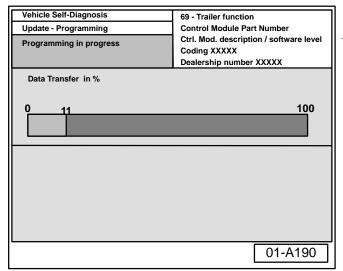
- Similar screen appears:
 - ◆ Previous data in the Control Module is erased and new data is being transferred to the module from the flash CD.

Approx. flashing time is 5 minutes.

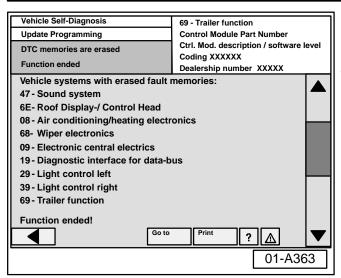
Once fault memories have been erased:

- Similar screen appears.
 - ◆ Function ended appears at bottom of screen.
