**Subject: Update Programming to Eliminate Possible Engine Stumble or Rough Running Condition (OD)**

**Number: 05-15**

**Model(s): Touareg 3.2L V6 (Eng. code BAA, BMX) 2004 ► 2005 Date: Dec. 19, 2005**

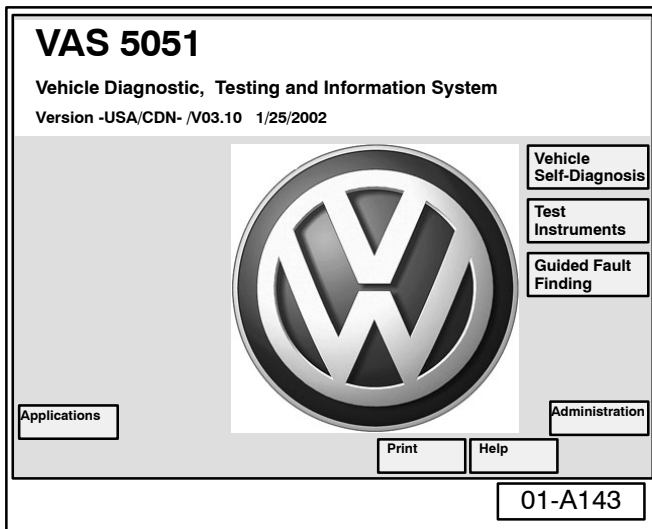
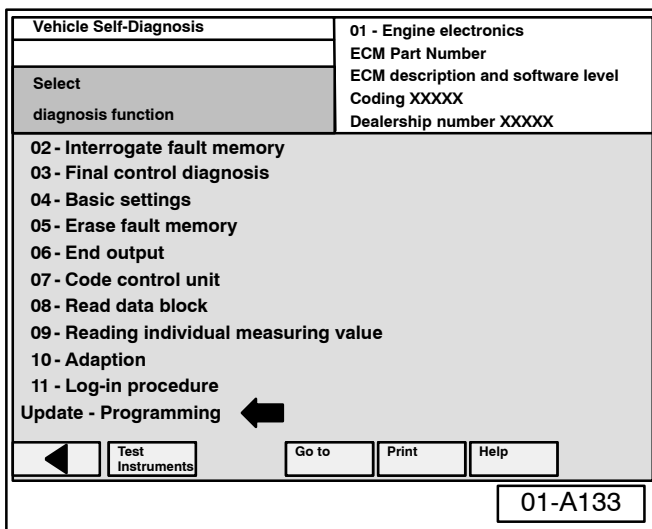
### Tip:

*The “Update - Programming” function is only available when the inserted flashing CD level and current vehicle ECM level are different.*

If "Update - Programming" does not appear:
