*Necessary preliminary tasks:*

- Remove A-pillar trim
- Remove glovebox
- Remove decorative trims for instrument panel

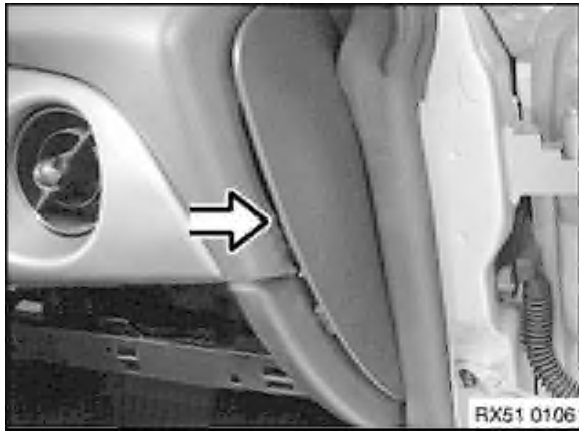
Lever out cover on left and right in direction of arrow.

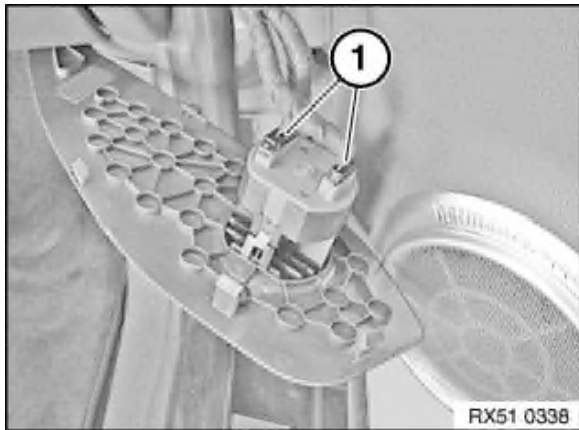
With passenger airbag deactivation optional extra only:

Unlock plug connections (1) and disconnect.

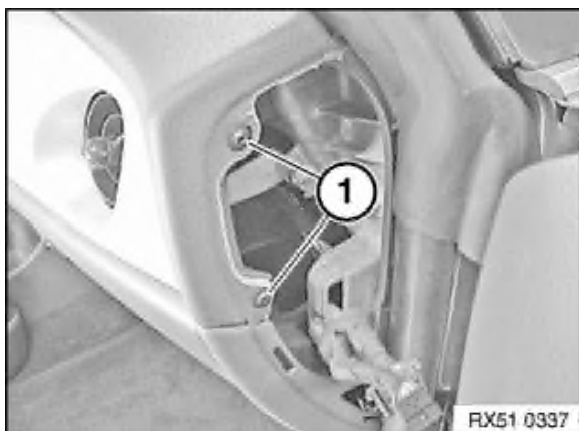
Release left and right screws (1).

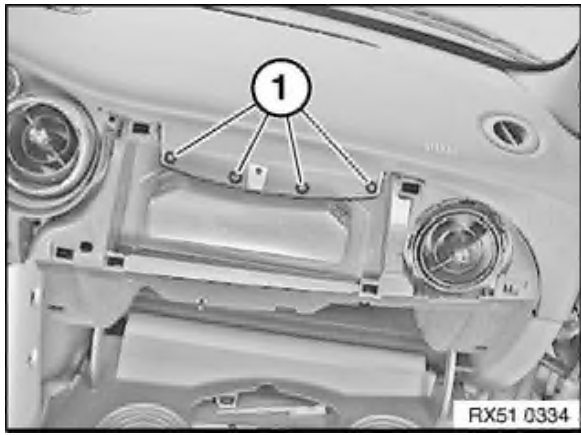
Release screws (1).

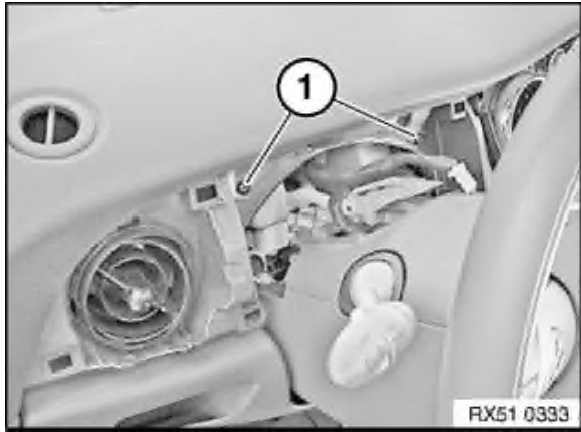
Release screws (1).

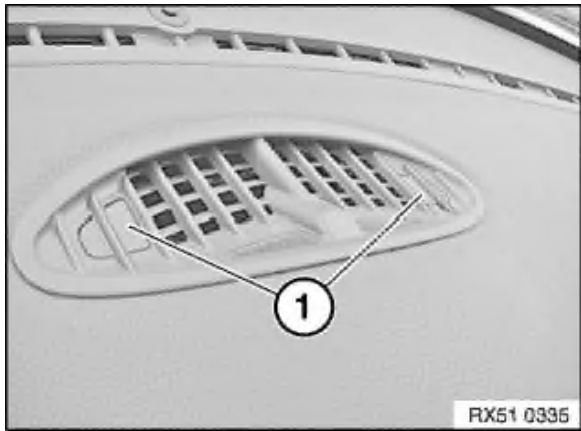
Lever out cover caps (1) in ventilation grille and release screws underneath.

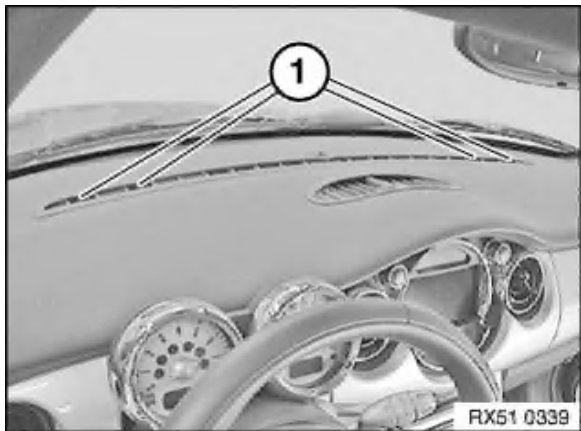
Release screws (1) in ventilation grille.

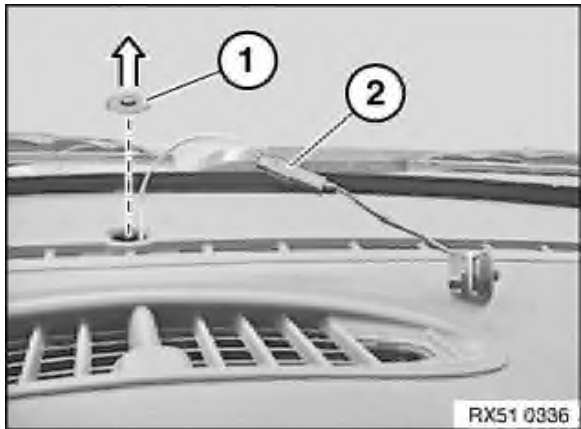
With automatic air conditioning optional extra only:

Tape off work area around solar sensor (1) (risk of damage).

Remove solar sensor (1).

Firmly pull solar sensor (1) upwards to release binding (adhesive tape inside instrument panel).

Feed plug connection (2) out of instrument panel and disconnect.

Wrap adhesive tape round plug connection to prevent rattling noises.

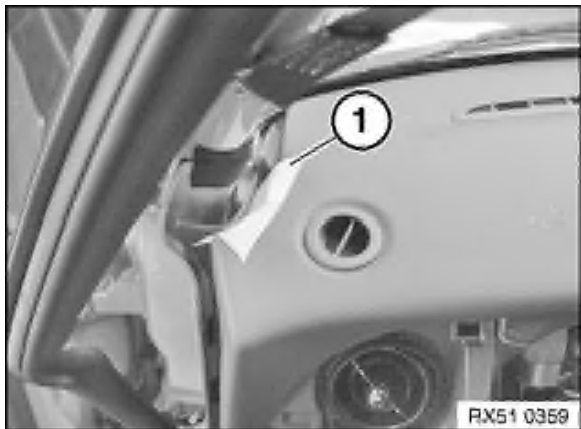
Protect trim with adhesive tape (1) against damage.

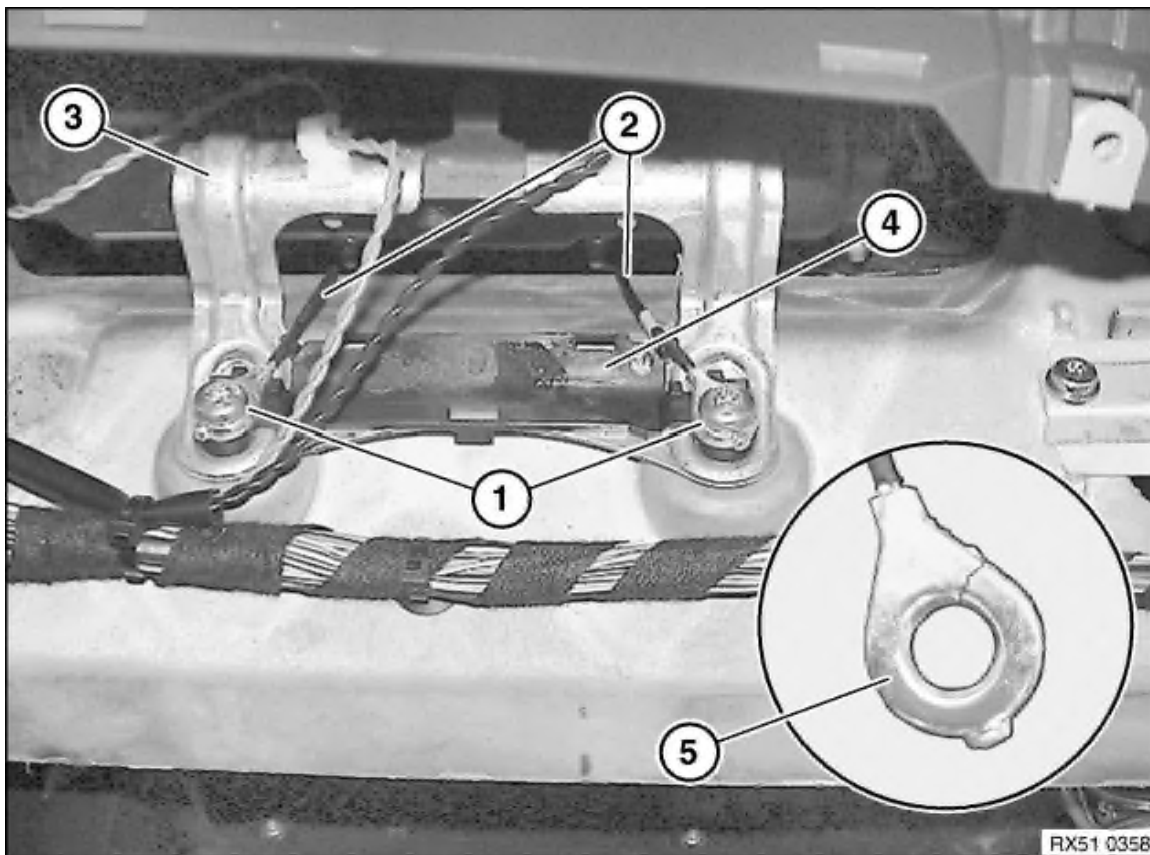
Broken eyelets (5) or damaged restraint cables (2) can cause injuries due to uncontrolled tearing off of the

airbag cover when the airbag is triggered.

Instrument panel upper section trim must be replaced if eyelets (5) are damaged or restraint cables (2) are damaged.

In order to prevent damage to eyelets (5), make sure spacer (4) is fitted; retrofit if necessary.

Release screws (1).

Tightening torque 72 12 7AZ .

Remove instrument panel upper section towards top and feed out restraint cables (2) between airbag module and instrument panel lower section.

Restraint cables (2) must be located between bracket (3).

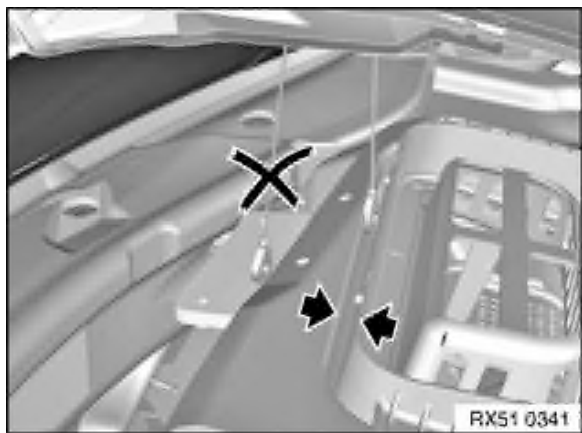
Insert restraint cables in gap between airbag module and instrument panel lower section.

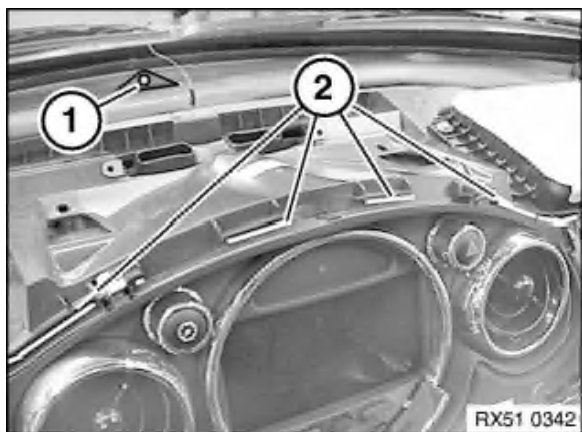
Insert centering pin of instrument panel upper section correctly into locator (1).

Lift instrument panel upper section in front area over guides (2).

Push in instrument panel upper section as far as it will go.

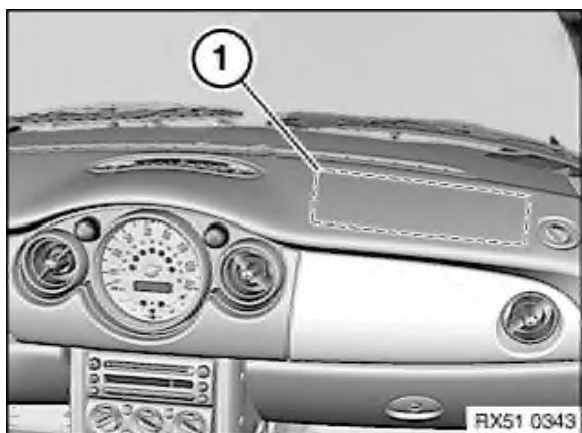
Do not strike area (1) of instrument panel upper section with fist.

Laser seam of airbag cover must now show in foam film.

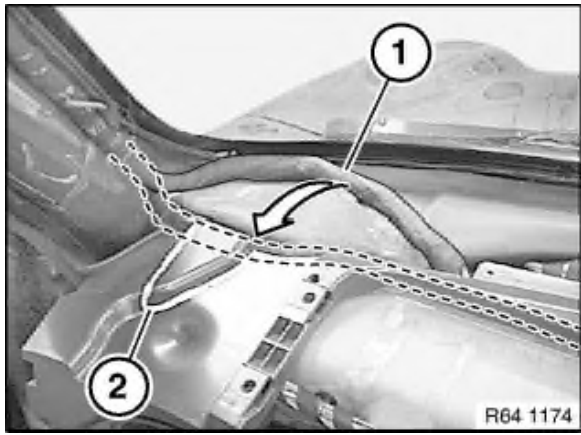
Build date from 03/04 - 07/04:

Air duct cutout must be adapted for a new instrument panel upper section.

Cut out instrument panel in marked area (2).

Lay wiring harness (1) between instrument panel and bulkhead.

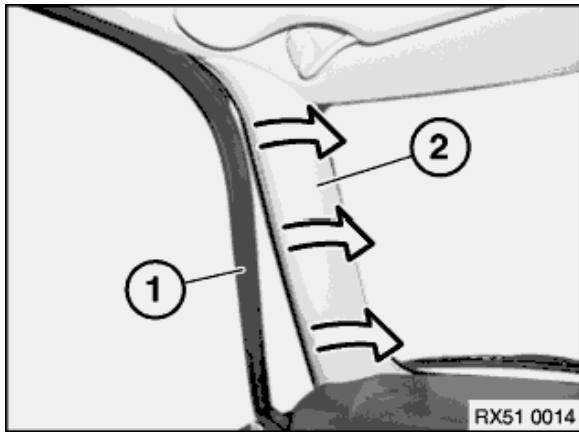
Release door seal (1) in area of panel (2).

Release panel (2) at top end in direction of arrow and remove.

If necessary, replace faulty clips.

Make sure door seal (1) is correctly seated.

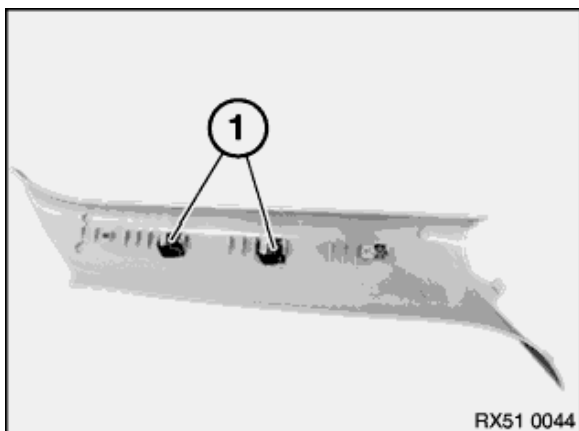
Cut through retaining straps on clips (1) and remove panel.

Remove clips from body.

Dispose of panel and clips.

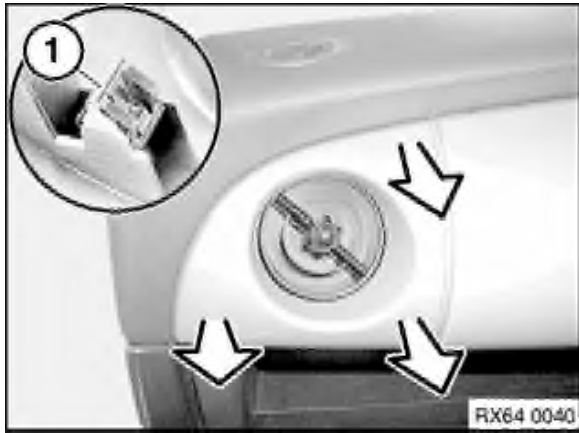
Unclip the decorative trim opposite in stages.

Unclip decorative trim in direction of arrow and remove.

If necessary, replace faulty clips (1) on decorative trim.

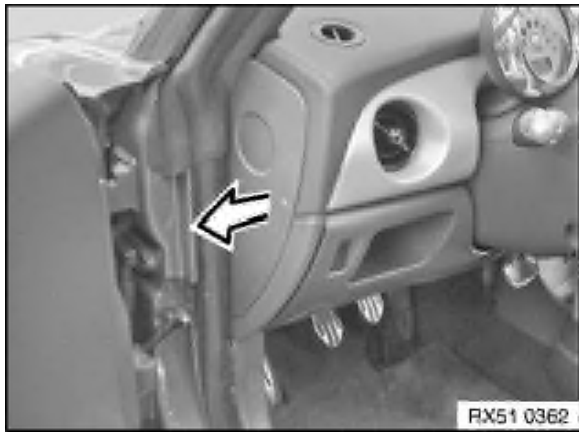
Lever out cover in direction of arrow.

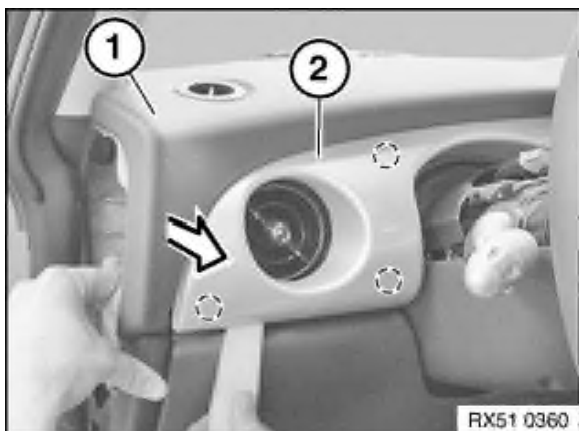
Pull instrument panel trim (1) forwards.

Unclip decorative trim (2) in stages.

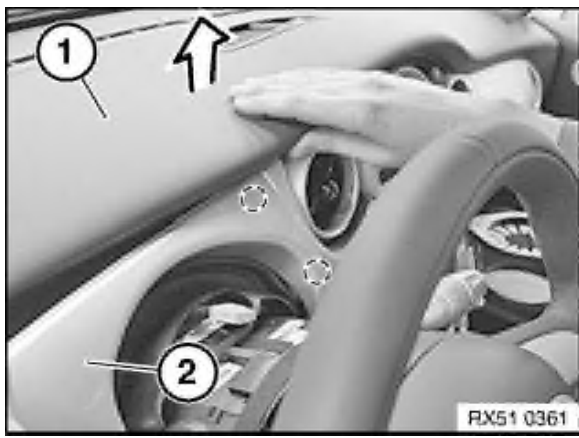
Press instrument panel trim (1) upwards.

Carefully unclip decorative trim (2) and twist out of instrument panel trim.

If necessary, replace faulty clips on decorative trim.

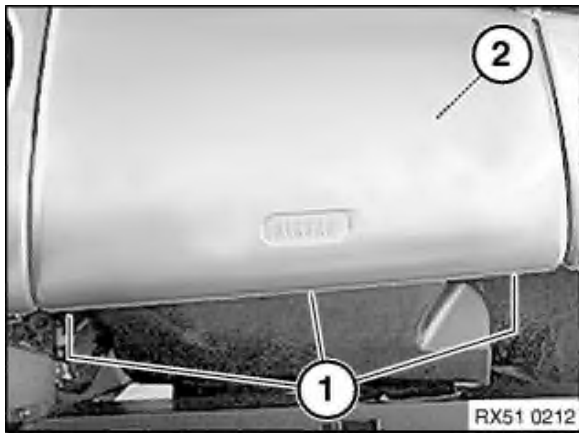
Release screws (1).

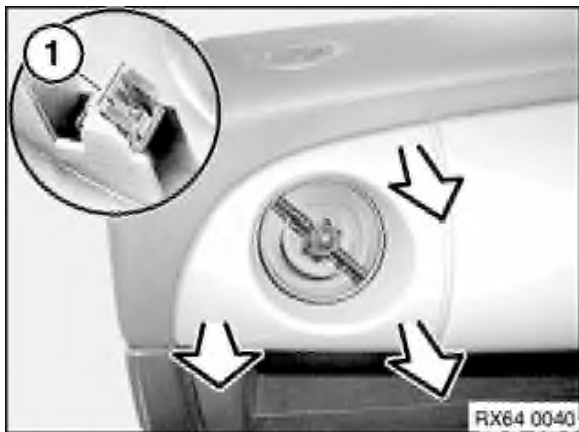
Release two screws on underside of decorative trim.

Unclip decorative trim in direction of arrow and remove.

If necessary, replace faulty clips (1) on decorative trim.

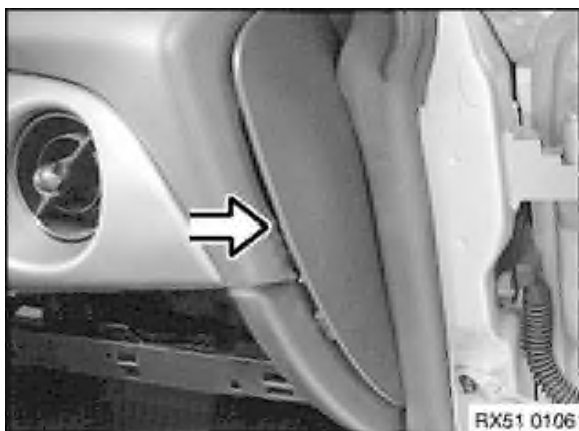
Lever out cover on right in direction of arrow.

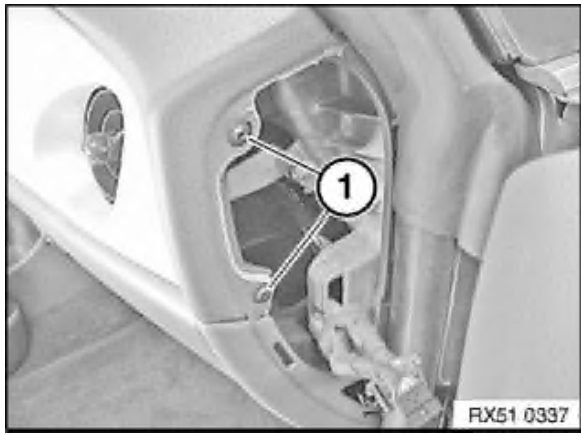
Release screws (1).

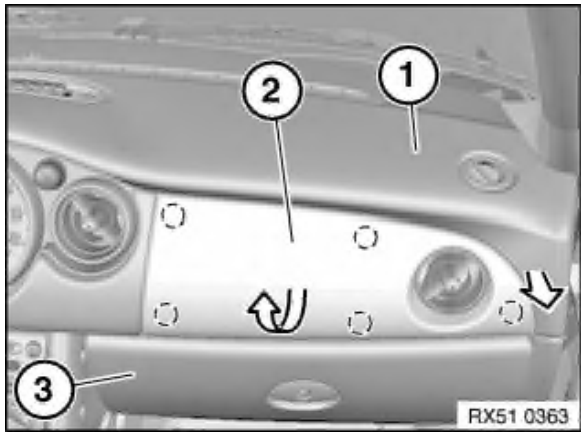
Open glovebox (3).

Pull outer instrument panel trim (1) on right towards front and hold.

Unclip decorative trim (2) in direction of arrow and remove.

If necessary, replace faulty clips on decorative trim.

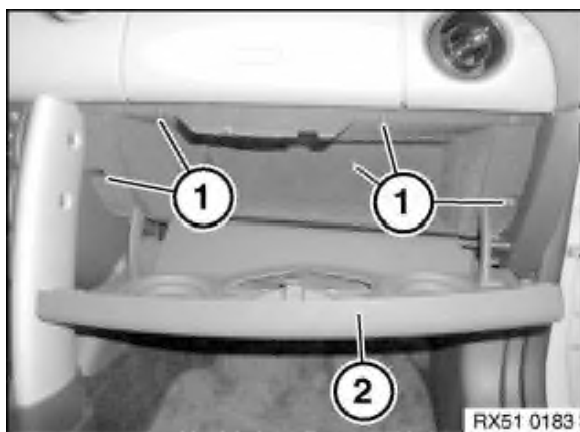
Release screws (1).

Remove glovebox (2).

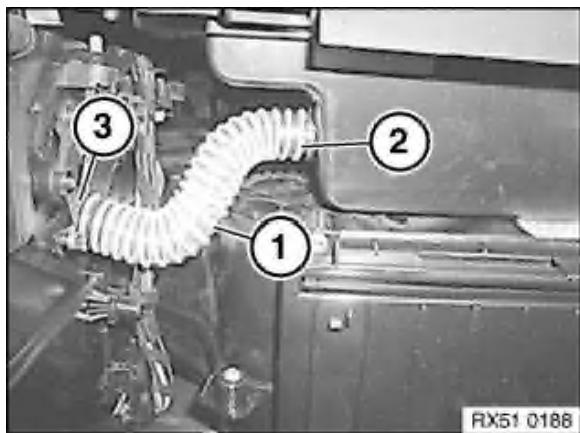
Connect cold-air duct (1) correctly to cold-air control (2) and heater (3).
