# Service Action Circular

**Code: XP**

**Subject: 2005 Model Year Touareg Vehicles With V6 Engine  
Affix Laminate Overlay with Vehicle Weights to  
Safety Certification Label**

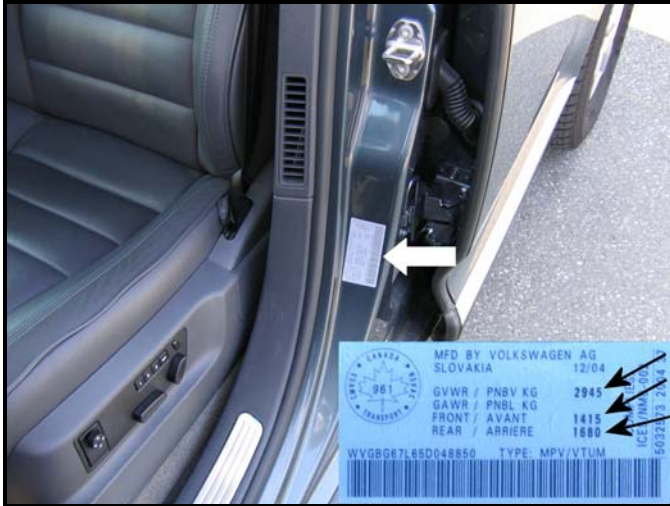
- Open driver's door
- ⇐ Locate safety certification label on B-pillar -white arrow- and check for vehicle weights identified as the GVWR, GAWR FRONT/REAR Kg -black arrows-
  - If weights are present, no further work is required
  - If weights are not present, proceed to next step

- Thoroughly clean safety certification label and the surface around it

**Note:** Inadvertent adhesion of laminate overlay may not be removed without damage to certification label

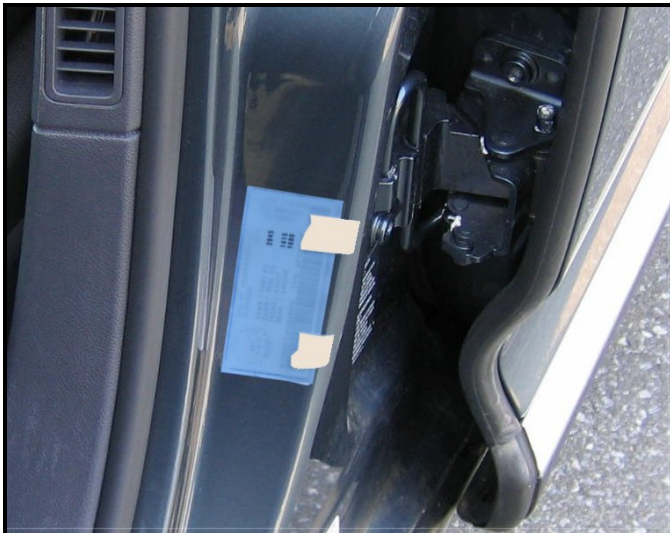
- ⇐ Position laminate overlay (XPC 000 001) with backing intact, over safety certification label, ensuring vehicle weights align horizontally with GVWR (2945) and GAWR FRONT (1415) and REAR (1680)

**Note:** Laminate overlay should cover certification label with edges aligned

- ⇐ Secure laminate overlay position using masking tape along bottom edge
- ⇐ Check that the weights are still aligned horizontally with GVWR and GAWR FRONT and REAR

**Note:** Laminate backing slides very easily on safety certification label.

Laminate must not move while removing backing

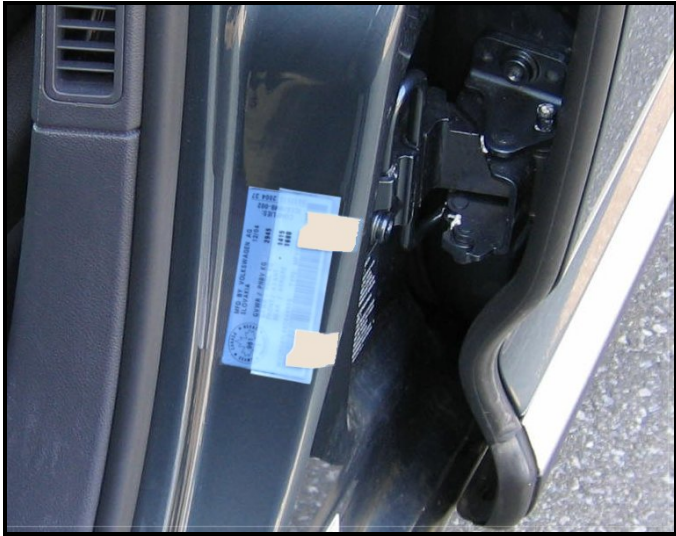
- Fold back the upper section of laminate overlay and carefully remove backing
- ⇐ Press laminate overlay onto the safety certification label making sure no bubbles appear under the laminate overlay
- Remove masking tape securing lower part of laminate

Note: Laminate backing slides very easily on safety certification label.

Laminate must not move while removing backing

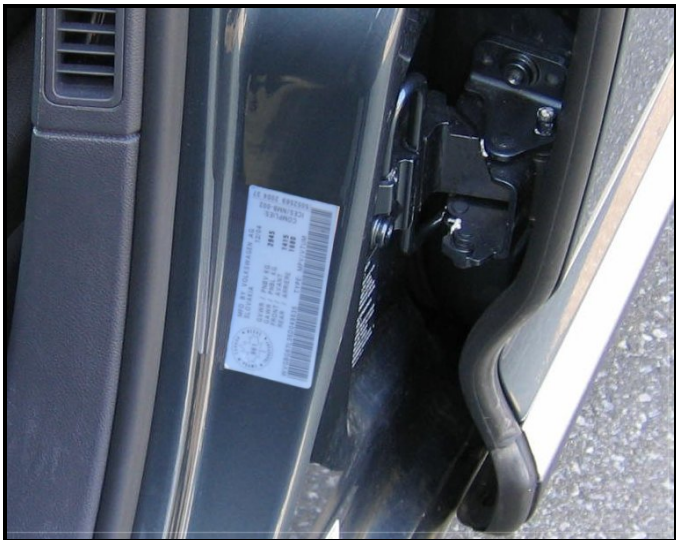
- Lift lower section of laminate overlay and carefully remove backing
- Press laminate overlay fully onto safety certification label making sure no bubbles appear under the laminate overlay
- ⇐ GVWR weight and GAWR FRONT and REAR weights are on safety certification label
- Close door
